**ENGINEERING GEOLOGIC INVESTIGATION
PROPOSED SUBDIVISION
APN 527-27-047
14915 SHANNON ROAD
LOS GATOS, CALIFORNIA**

February 5, 2021
Project #2104

Subject: **ENGINEERING GEOLOGIC INVESTIGATION**
Proposed Subdivision
APN 537-27-047
14915 Shannon Road
Los Gatos, California

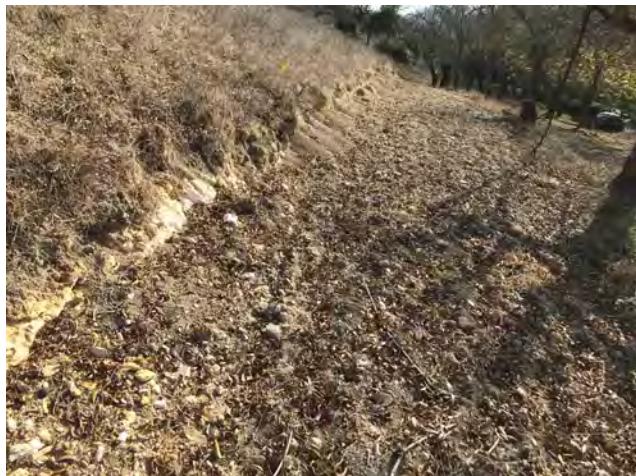
Bedrock exposures of Monterey Shale occur within cuts for dirt farm roads on the property, as shown on Photos 3 and 4 below. A bedding attitude was measured in a roadcut located on Lot 3, as shown on Figure 7. The bedding strikes towards the northwest and dips moderately towards the northeast.

Photo 3: View of Monterey Shale bedrock exposed in a roadcut on Lot 3.

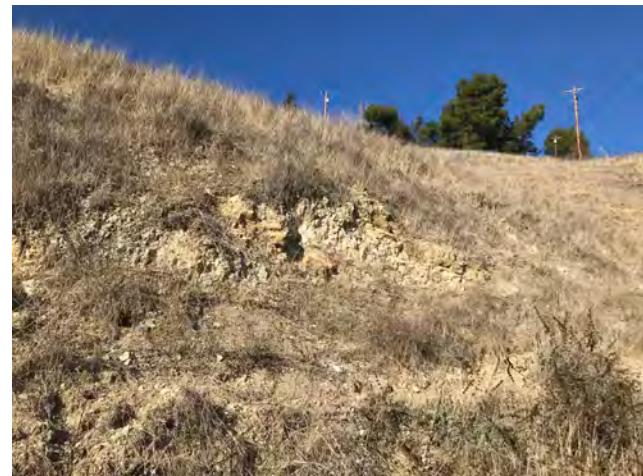
Photo 4: View of Monterey Shale bedrock exposed in a roadcut on Lot 7.

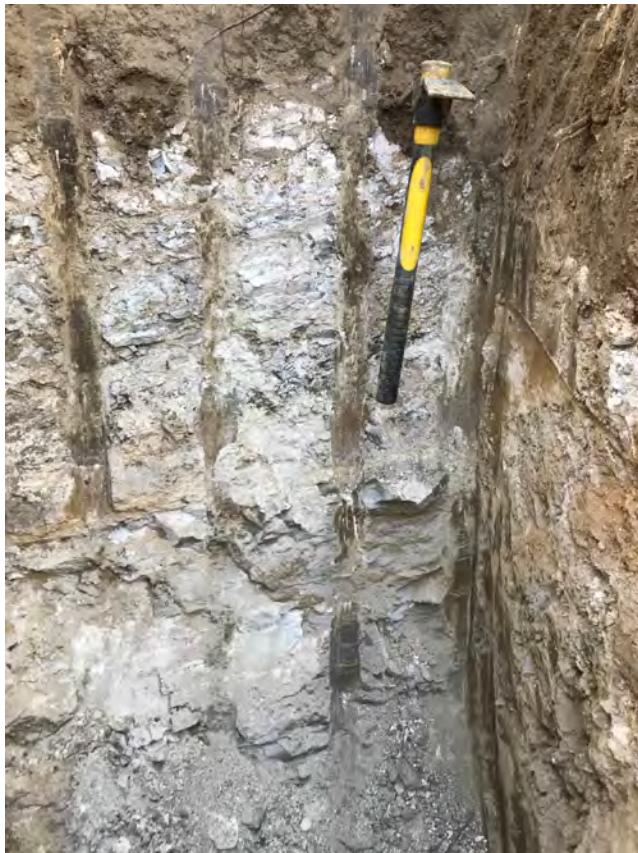
Photo 6: View of Monterey Shale bedrock exposed in Pit 1.

Test Pit 1 was excavated on Lot 1 and encountered about 2.5 feet of colluvial soil, composed of firm to stiff, low plasticity, silty clay. Weathered bedrock of the Monterey Shale composed of moderately bedded, moderately hard, siltstone and shale with white carbonate staining was observed, as shown on Photos 6 and 7 above. Bedding measured in Test Pit 1 strikes North 80 West and dips 50 degrees towards the North.

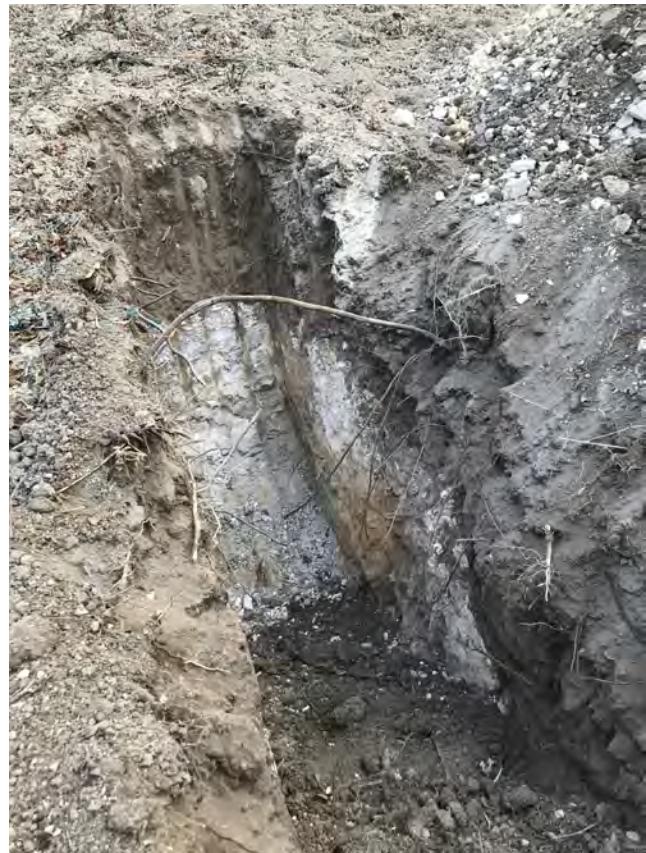
Photo 7: View of Monterey Shale bedrock exposed in Pit 1.

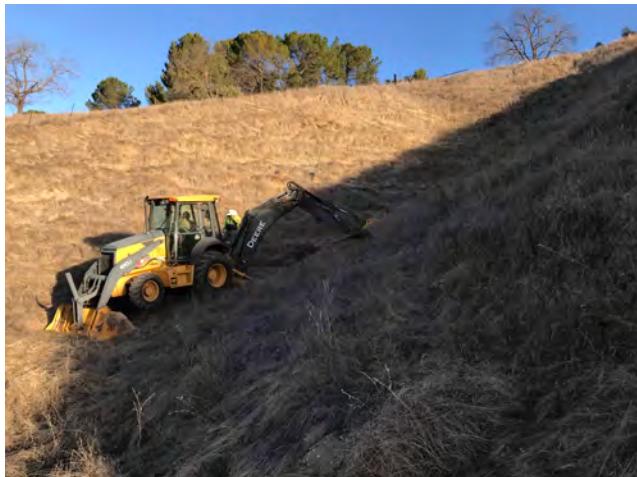
Four steeply-inclined bowl-shaped drainage swales are located on the steep southwest facing hillside on the property (see Photo 8 below). A smaller drainage swale is located on the eastern margin of Lot 7. These drainage swales appear to be potential debris flow source terrains, as approximately depicted on Figure 7, Site Geologic Map.

Photo 8: View of backhoe excavating Test Pit 9.

Based upon review of historic air photos, site reconnaissance, and subsurface investigation, steeply-inclined drainage swales on the property appear to be potential debris flow source terrains. Proposed homesites located below these drainage channels are subject to a significant debris flow landslide hazard. Consequently, I recommend avoidance or construction of debris walls to protect the proposed new residences from

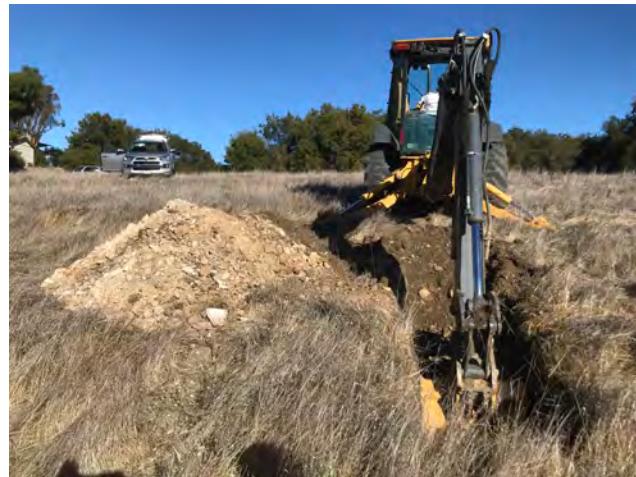
Test Pit 11 was excavated on the broad hilltop area on Lot 9, as shown on Photo 9 below. About 2.5 feet of colluvial soil underlain by weathered bedrock composed of siltstone and shale of the Monterey Shale.

Photo 9: View of backhoe excavating Test Pit 11.

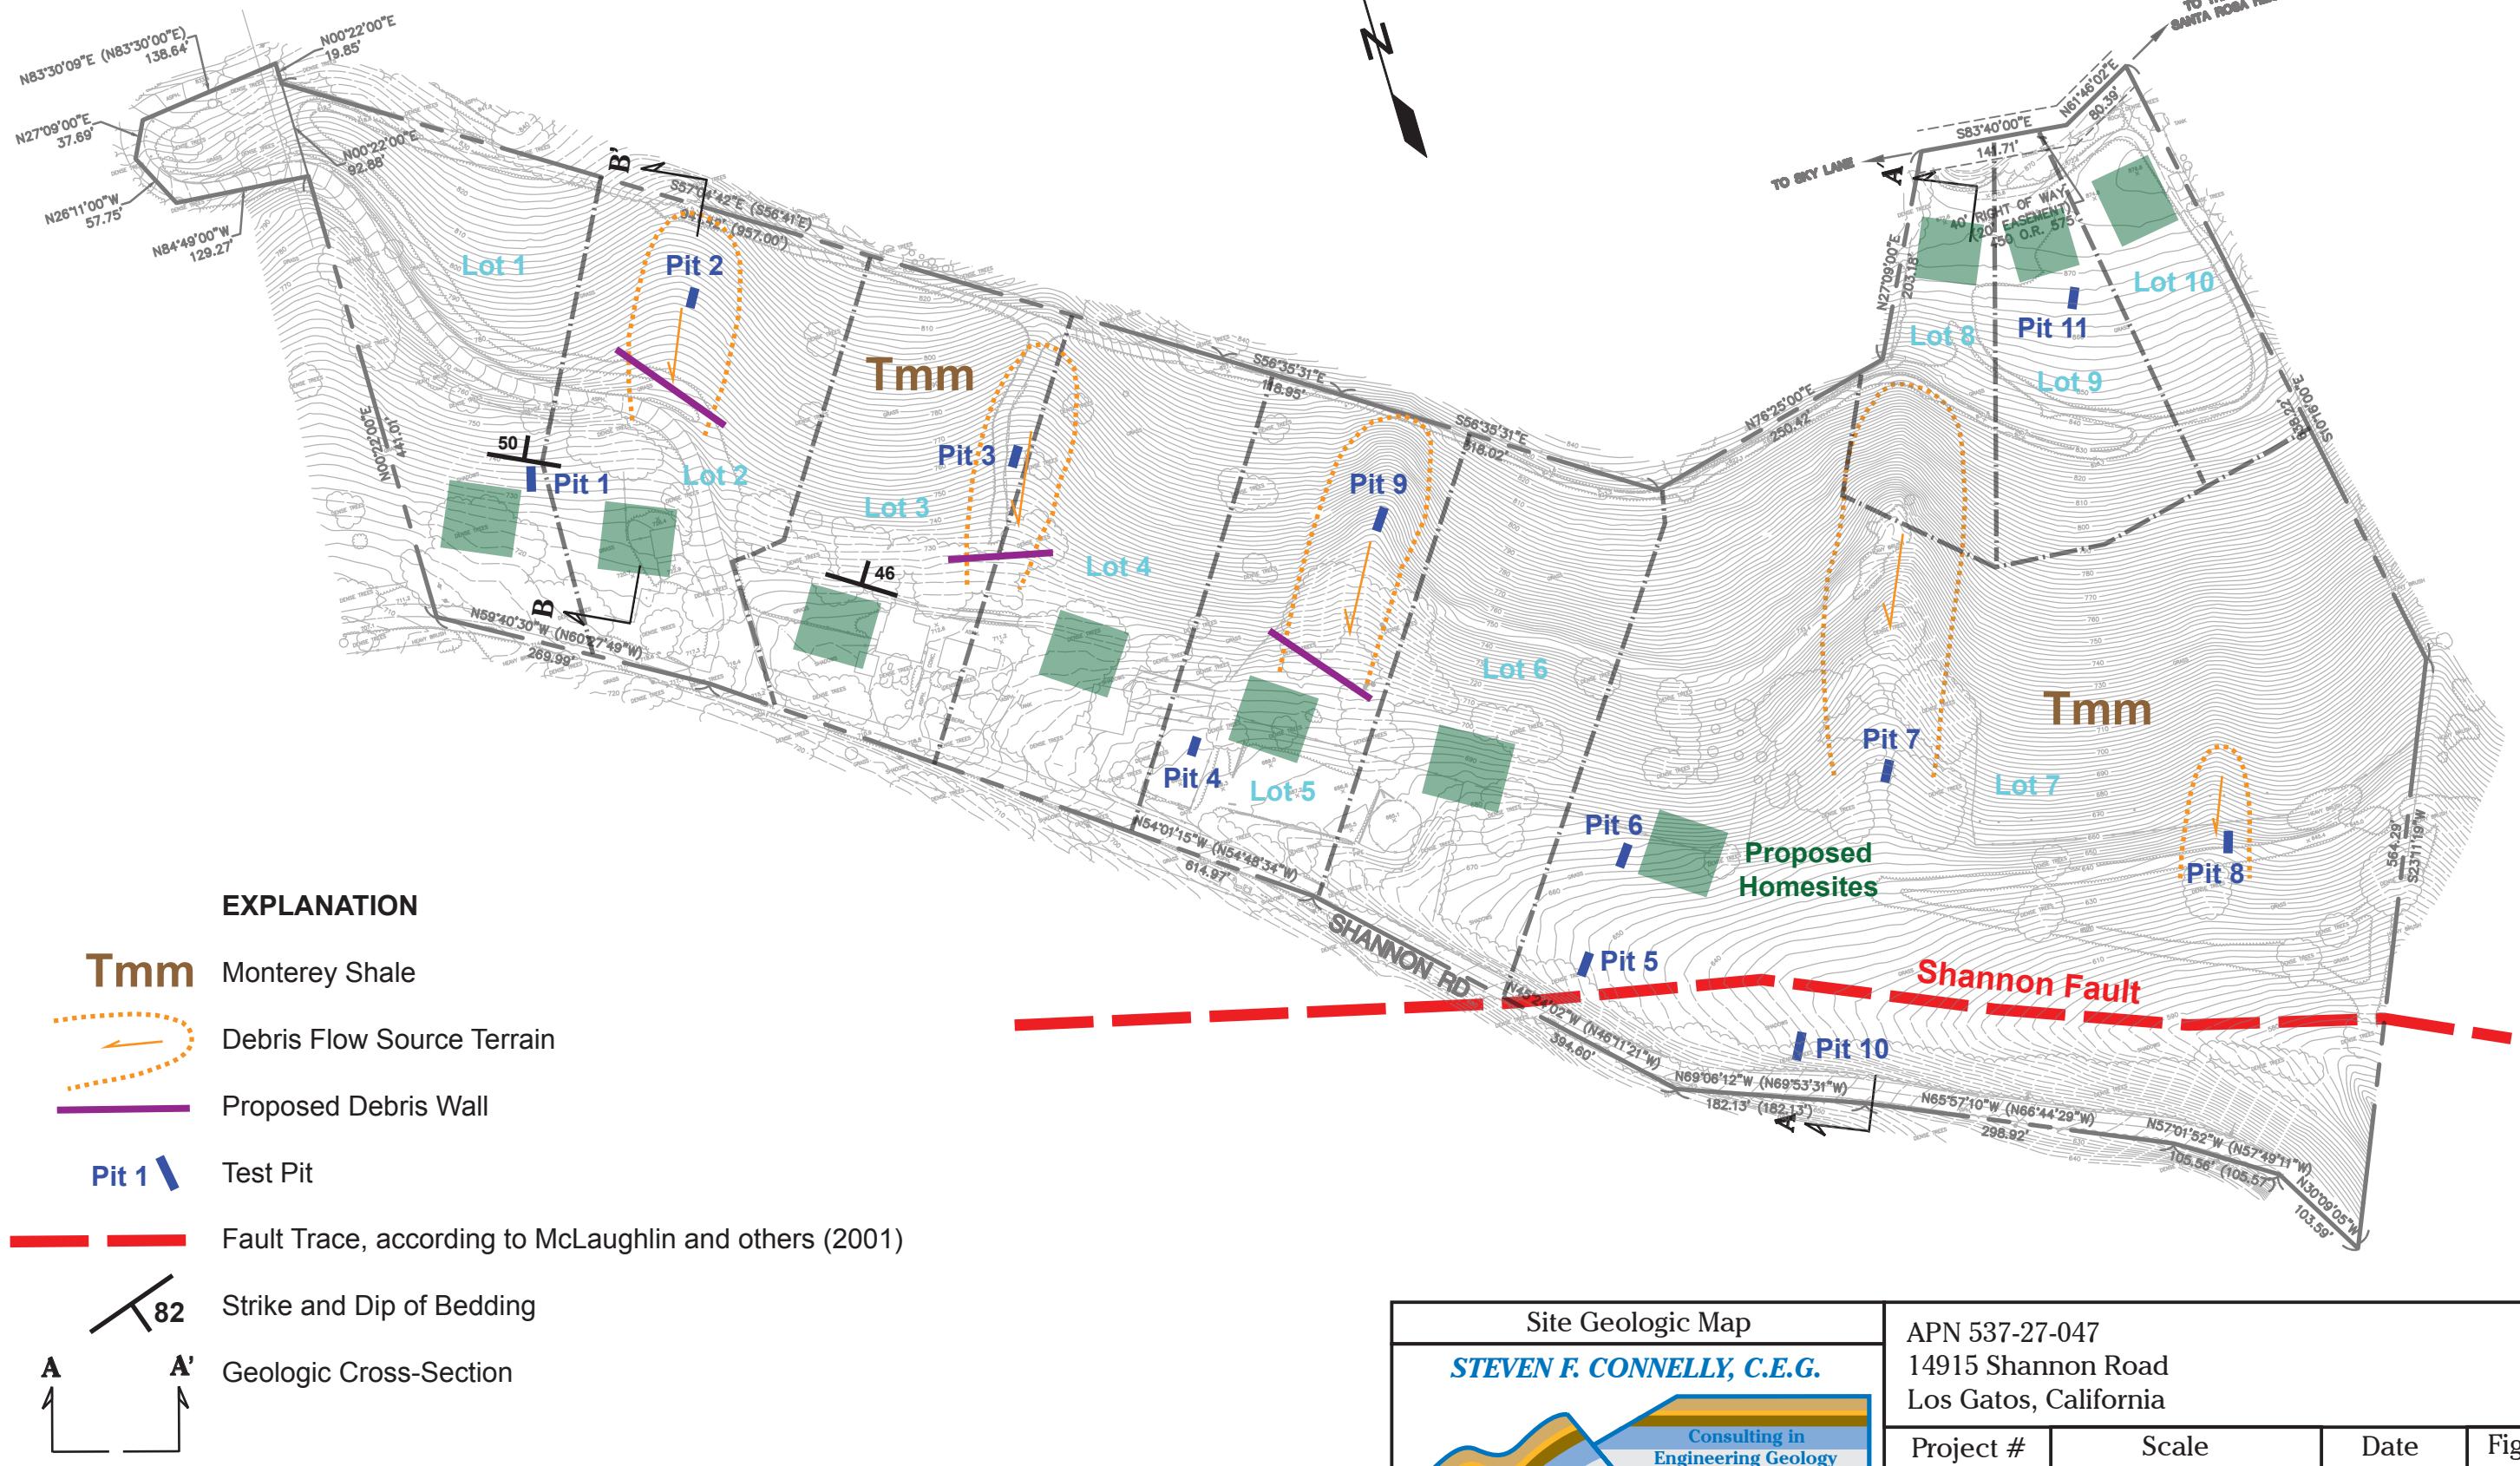
Based upon the results of this Engineering Geologic Investigation, a trace of the active Shannon fault has been mapped through the southwest margin of the property, as approximately shown on Figure 7. Further investigation is necessary to accurately define the fault location and determine appropriate fault setback recommendations. Thick soil deposits in the area, however, inhibit excavation to bedrock necessary to observe fault

relationships. A deep excavation with an excavator or bulldozer will be required to expose bedrock at depth. The proposed homesite on Lot 7 appears to be the only homesite potentially impacted by ground rupture hazards from the Shannon fault. The remaining homesites, in my opinion, are sufficiently removed from the Shannon fault and are not subject to primary ground rupture hazards due to active faulting.

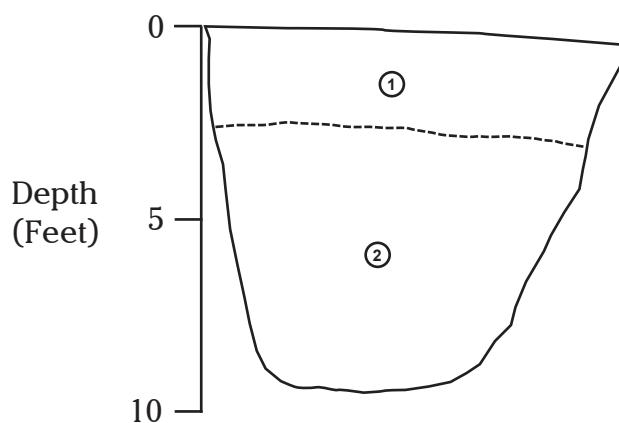
Log of Test Pit 4		APN 537-27-047			
STEVEN F. CONNELLY, C.E.G.		14915 Shannon Road Los Gatos, California			
		Project #	Scale	Date	Figure
		2104	1 Inch = 5 Feet	2/5/21	11

- ① dark grayish brown, 10YR6/2, silty clay, slightly moist, firm to stiff, low to medium plasticity, trace roots and rootlets, CL (Colluvial Soil)
- ② very dark grayish brown, 10YR3/2, clayey silt, slightly moist, stiff, low plasticity, trace roots, trace rock fragments of Monterey Shale to 1 inch, abundant fine white carbonate stringers, CL (Colluvial Soil/Slope Wash)
