ARBORIST REPORT

Blossom Hill Apartments
101 Blossom Hill Road, Los Gatos, CA

APN 529-11-036

Arborist Report at 101 Blossom Hill Road, Los Gatos, California

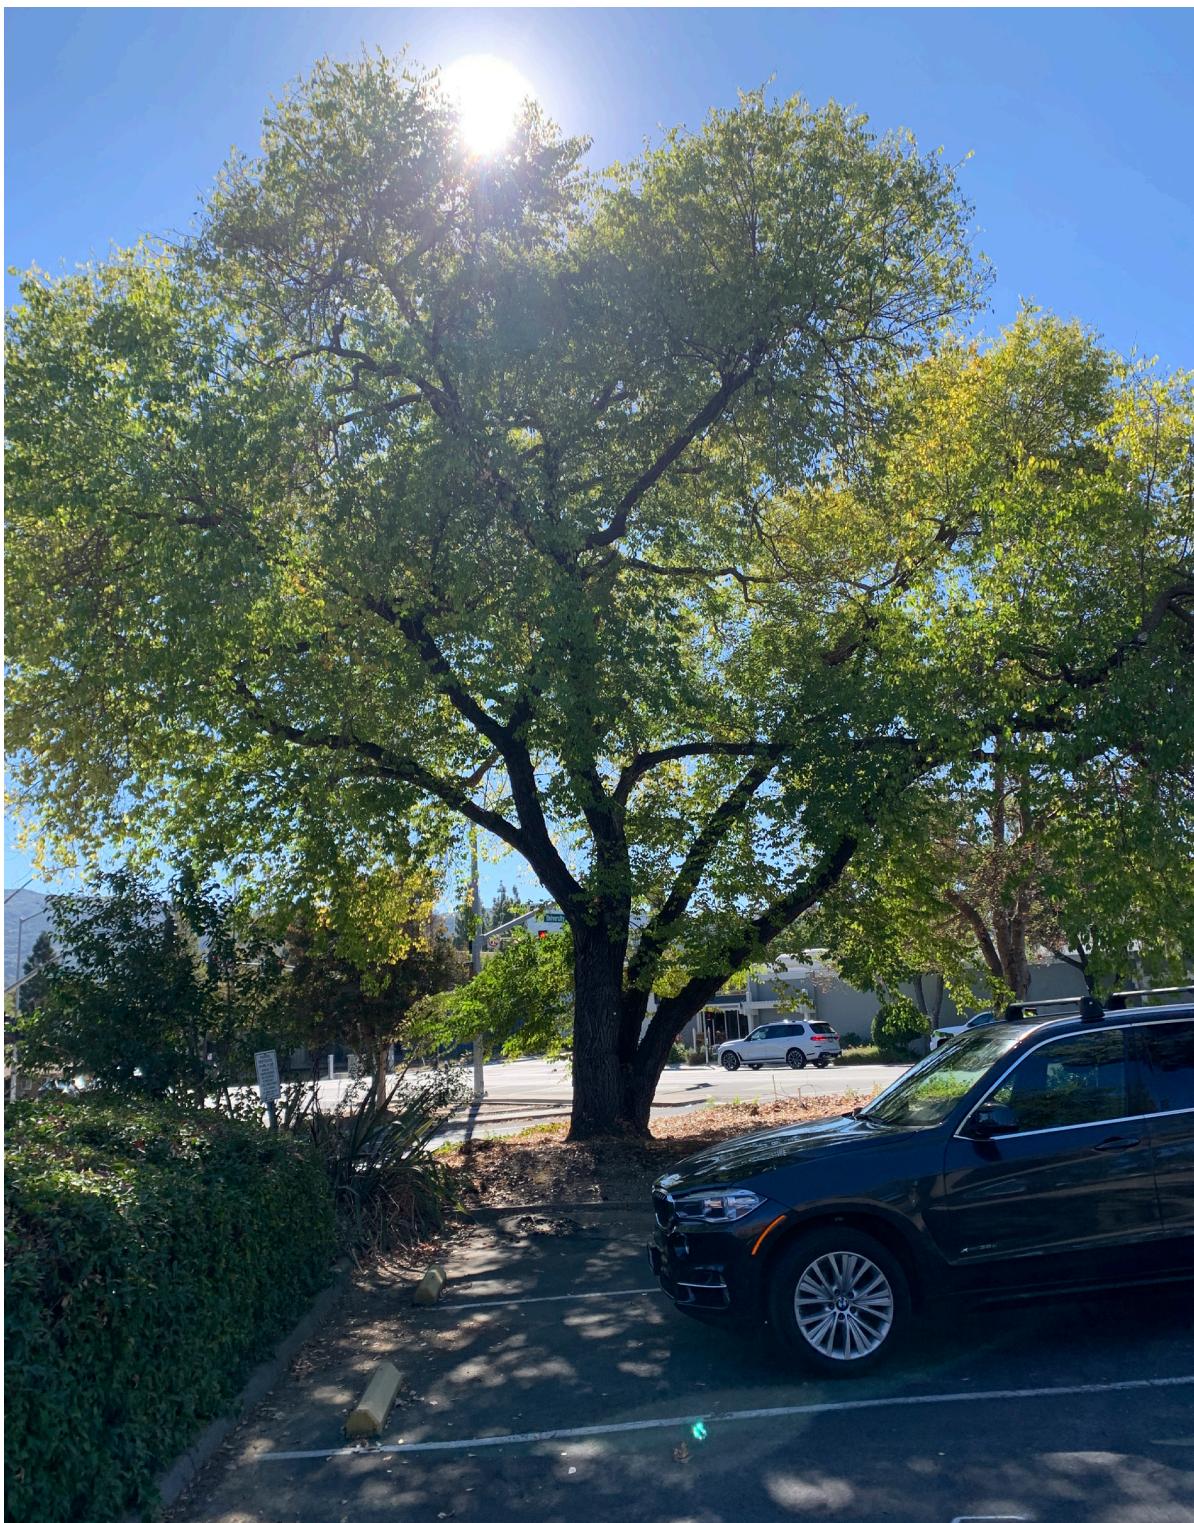
Tree #	SPECIES	DIA	S	H	RV	C	OBSERVATIONS/RECOMMENDATIONS	Impact	P	SAVE/ REMOVE
1	Siberian elm	25.5, 15.9, 16.6	3	3	3	43	Located at planting area at southeast corner of project. Tri-dominant branch union 3' above grade with included bark ¹ . Epicormic shoots ² at W and N leaders. Some previous prunings have not compartmentalized ³ . <i>Species noted as invasive. Consider removal.</i> If preserved, <i>Install Type 1 Tree Protection Fencing, see Tree Inventory & Protection Plan.</i>	None	P	TBD
2	Coast live oak	10, 10.5, 10	2	2	2	25	Located at planting rare at southeast corner of project. Tri-dominant branch union at 3' above grade with included bark ¹ . Abundant deadwood; intertwining limbs, pop-up spray head noted at base of tree. Jasmine located throughout understory. <i>Tree in severe decline, likely due to overwatering. Removal recommended.</i>	None	P	Remove
3	Eucalyptus blue gum	38	3	3	3	35	Located at existing parking lot island. Some narrow crotch unions in upper canopy. Tagged as 103. <i>Proposed site improvements require removal.</i>	Severe	P	Remove

Tree #1, Siberian elm at southeast corner of project.

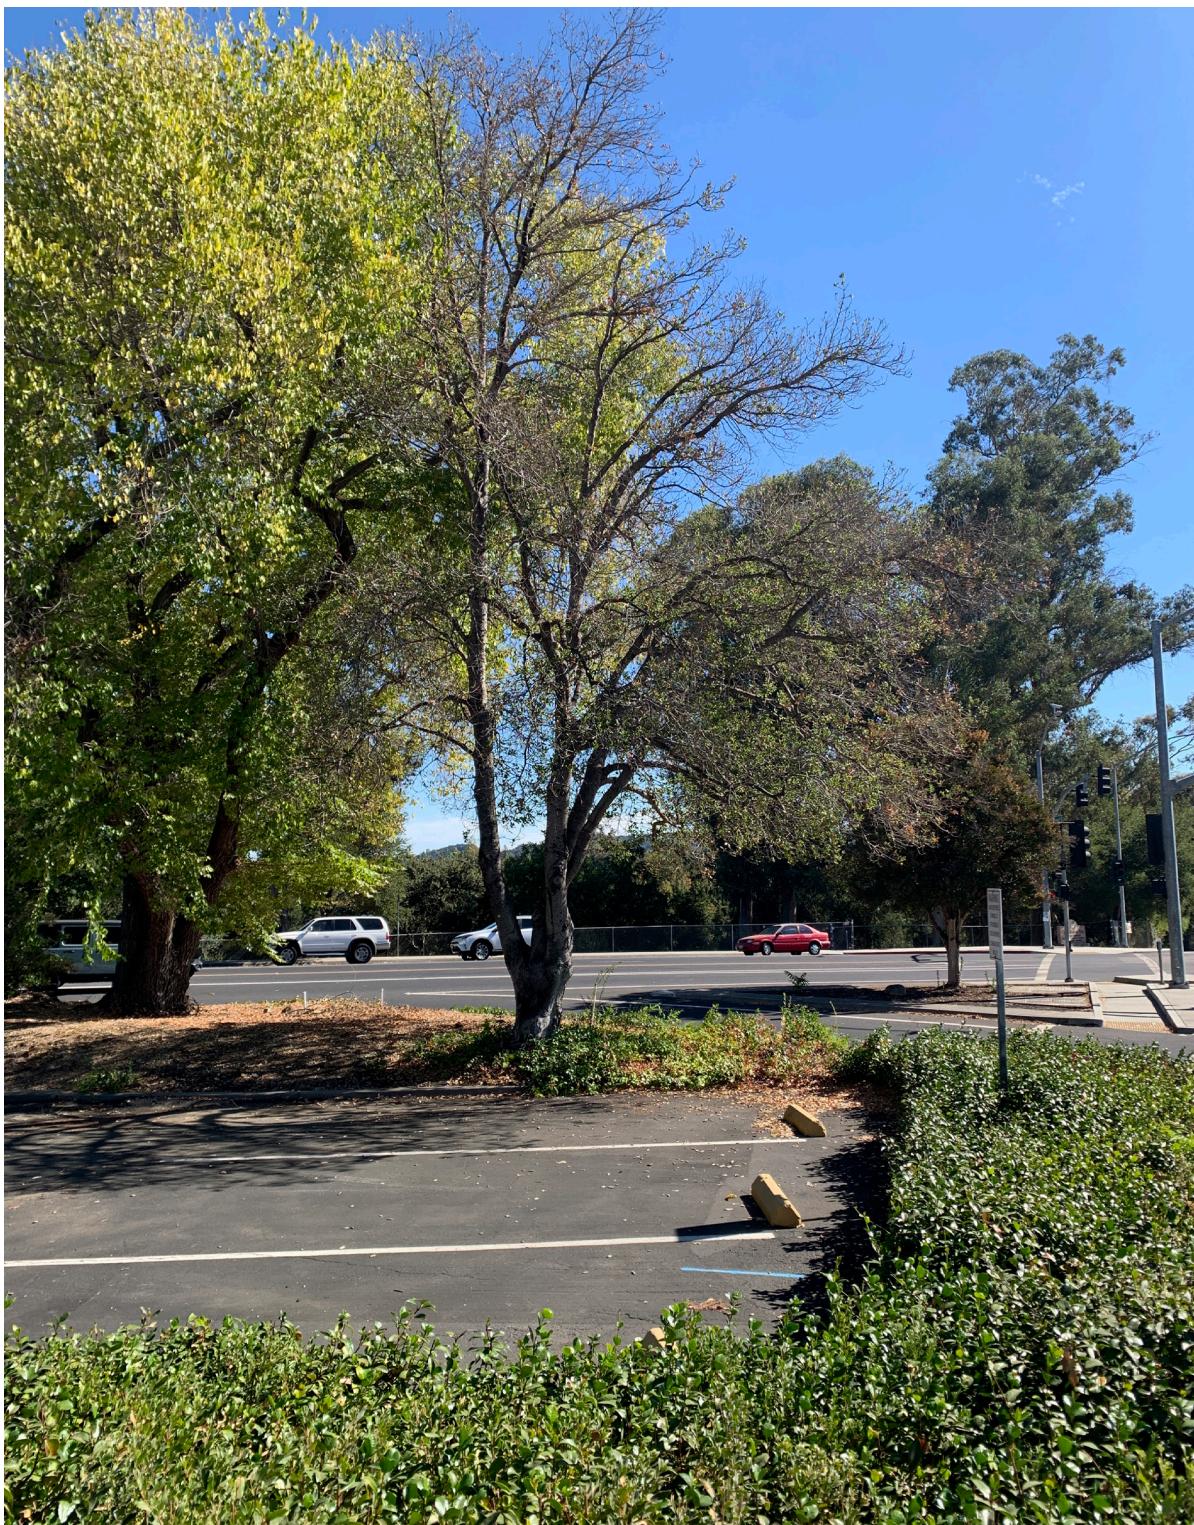
Tree #2, Coast live oak in severe decline, likely due to overwatering. Removal recommended.

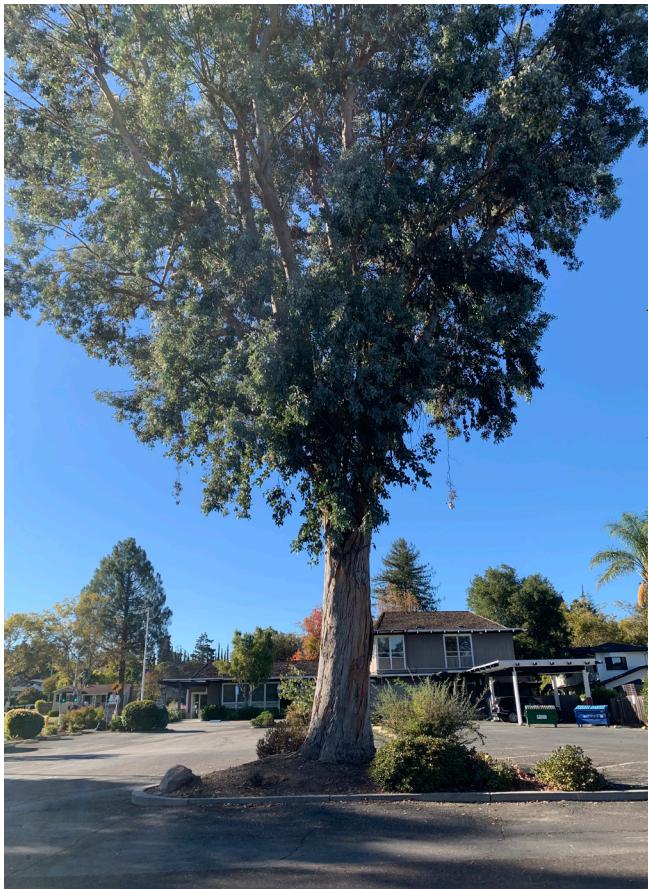
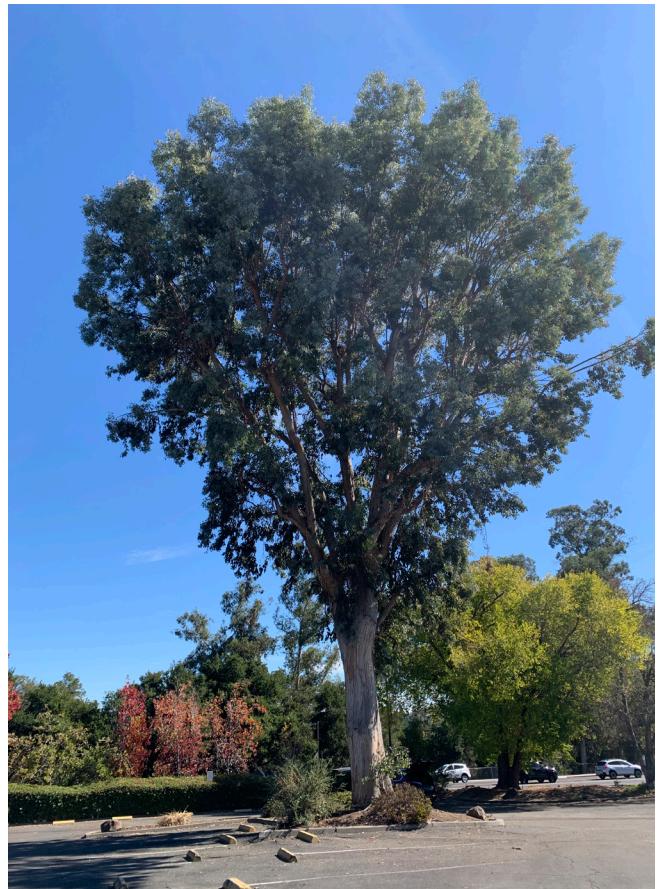
Tree #3, Blue gum eucalyptus located at planting area at existing parking lot island. Proposed site improvements require removal.

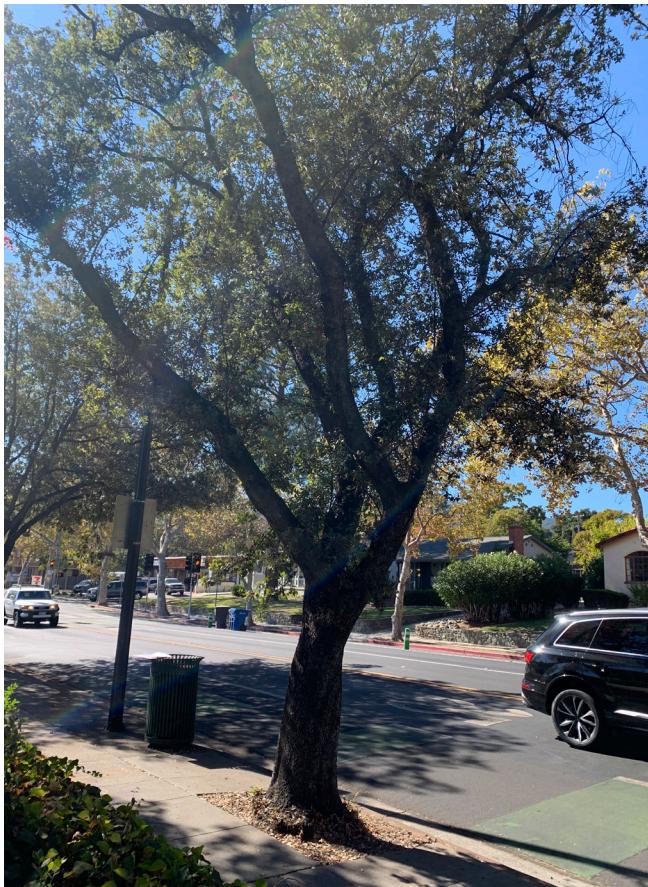
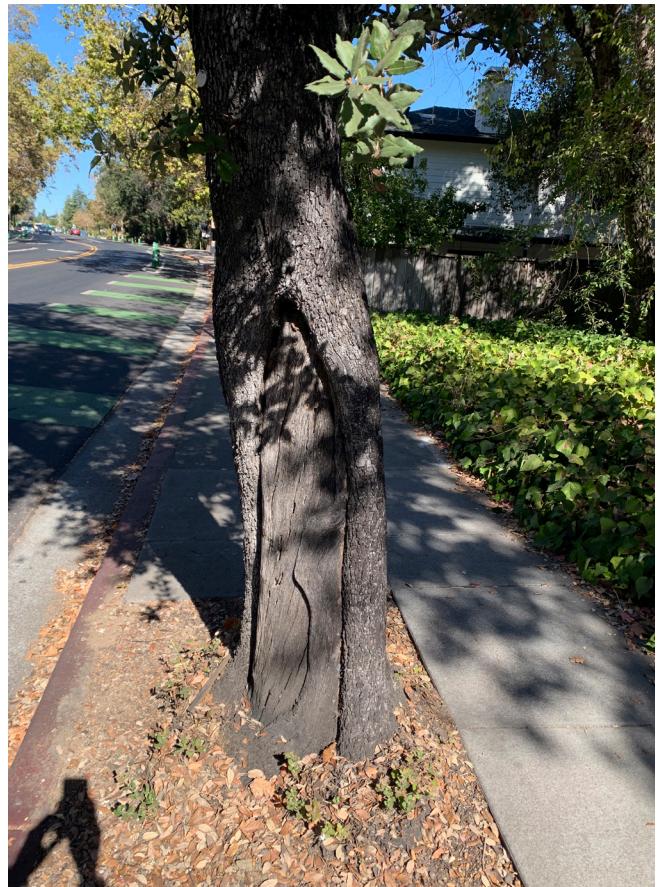
8	Canyon oak	17	2.5	3	3	25	Located along Santa Cruz Avenue. Street tree. Previously tagged #321. Missing bark up to 4' above grade with exposed phloem and heartwood. Codominant branch union 5' above grade; Epicormic shoots ² ; Multiple branches lopped off. <i>Install Type 2 Tree Protection Fencing, see Tree Inventory & Protection Plan.</i>	None	P	Save
9	Siberian elm	18.1	3	2.5	2.5	25	Located near NW corner of existing buildings. Crowded by #10. Decisive lean to SW over bus stop. Moderate deadwood. Intertwined leaders in upper canopy. Infected, suspected leafspot. Growing ivy. <i>Located approximately 10' from proposed building envelope. Removal recommended.</i>	Moderate to significant	P	Remove

Tree #8, Canyon oak located along Santa Cruz Avenue (street tree to remain and be protected). Missing bark with exposed phloem and heartwood.

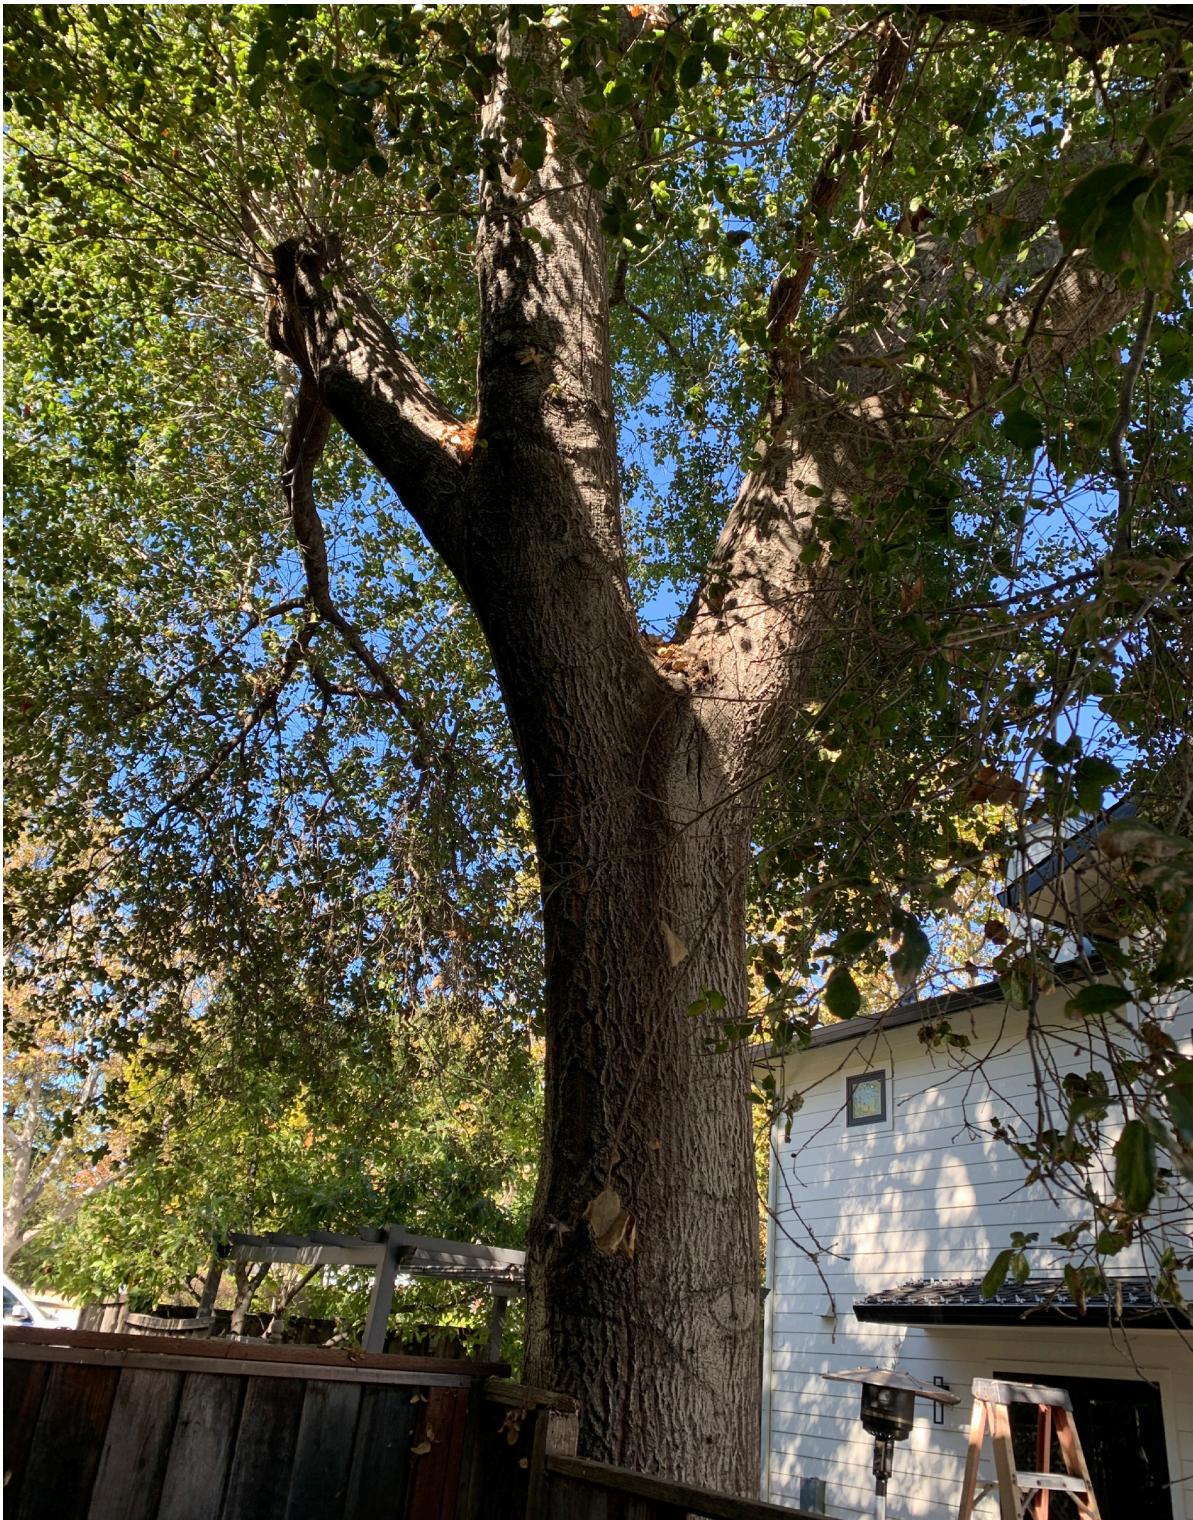
Tree #	SPECIES	DIA	S	H	RV	C	OBSERVATIONS/RECOMMENDATIONS	Impact	P	SAVE/ REMOVE
10	Coast live oak	~28	3	3.5	4	45	<p>Not shown on survey. Located off site just outside perimeter fence near NW corner of existing building. Previous pruning has produced a lion's tail.</p> <p><i>Canopy extends ~13' feet into subject property. Install Type 1 Tree Protection Fencing, see Tree Inventory & Protection Plan.</i></p> <p><i>SEE TREES THAT MERIT SPECIAL ATTENTION below.</i></p>	Minor to moderate	P	Save
11	Liquidambar	10.8	3	3	3	12	<p>Located between existing building and sidewalk along Santa Cruz Avenue.</p> <p>Narrow, columnar form; growing in ivy (ivy surrounds base); narrow branch unions. Codominant branch union 18' above grade with included bark¹</p> <p><i>Within proposed building footprint.</i></p>	Severe	P	Remove
12	Liquidambar	10	2.5	2.5	2.5	16	<p>Located between existing building and sidewalk along Santa Cruz Avenue.</p> <p>Hollowed-out eastern leader with decay. Lopped off at 15' above grade. Oozing sap along central leader at 4' above grade. Codominant branch union 7' above grade with included bark¹. May present a hazard if eastern leader were to fail.</p> <p><i>Within proposed building footprint. Due to noted hazard, removal is recommended ASAP.</i></p>	Severe	P	Remove

Offsite tree located at northwest corner of project site just outside the perimeter fence. The existing building is located 13' from root crown. The proposed building is located 19 ½' from root crown. The proposed subterranean garage will need to be well outside the dripline of the tree.

Tree #10, Coast live oak located off-site outside perimeter fence. See "Trees that Merit Special Attention."

1. Per discussions with the project team, the underground garage has been adjusted to accommodate the tree.
2. May require clearance pruning for proposed building. Retain an arborist to execute.
3. Retain arborist to be on-site at time of demolition of the existing building.
4. Retain arborist to be on-site at the time of excavation for the proposed underground garage.
5. Retain arborist to be on-site at the time of excavation for the foundation of the proposed building. If significantly sized roots are discovered, pier foundations may be warranted to avoid root disturbances.

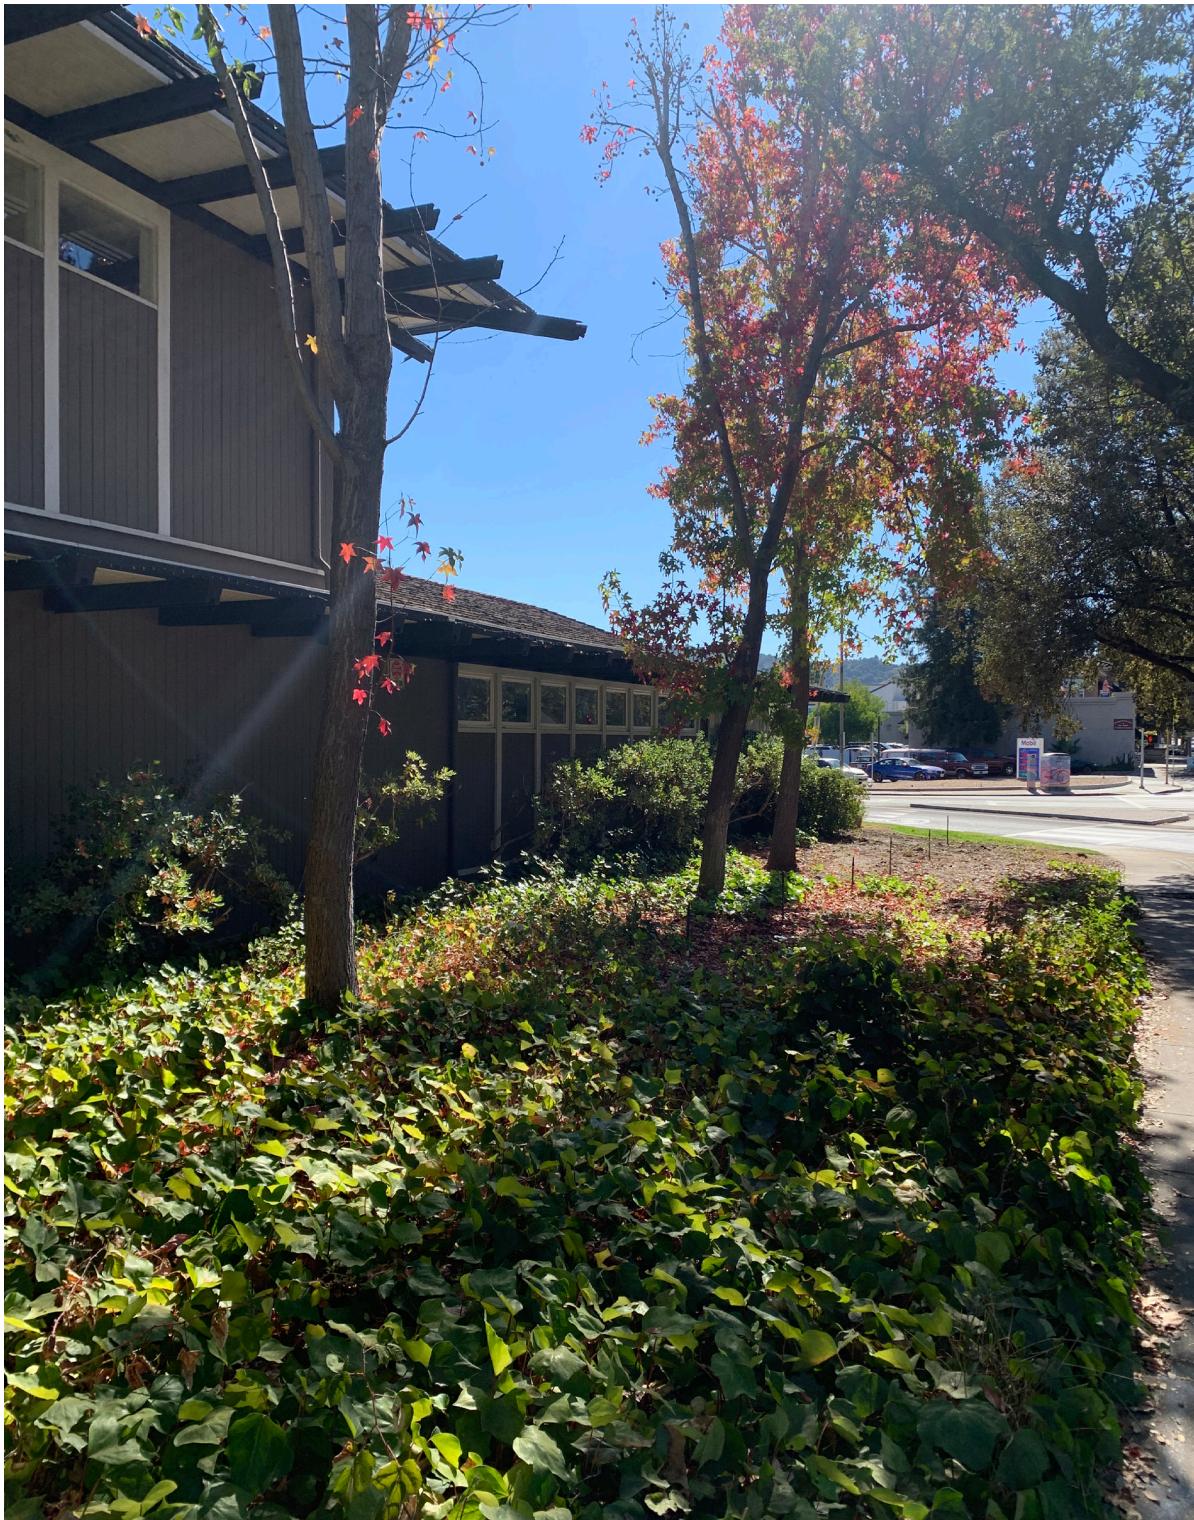
13	Liquidambar	11.2	3	3	3	15	<p>Located between existing building and sidewalk along Santa Cruz Avenue.</p> <p>Girdling roots⁴.</p> <p><i>Within proposed building footprint.</i></p>	Severe	P	Remove

Trees #11, 12, 13 - Liquidambars located between existing building and sidewalk along Santa Cruz Avenue. Proposed building footprint requires removal of all three trees; removal of #12 is recommended ASAP.

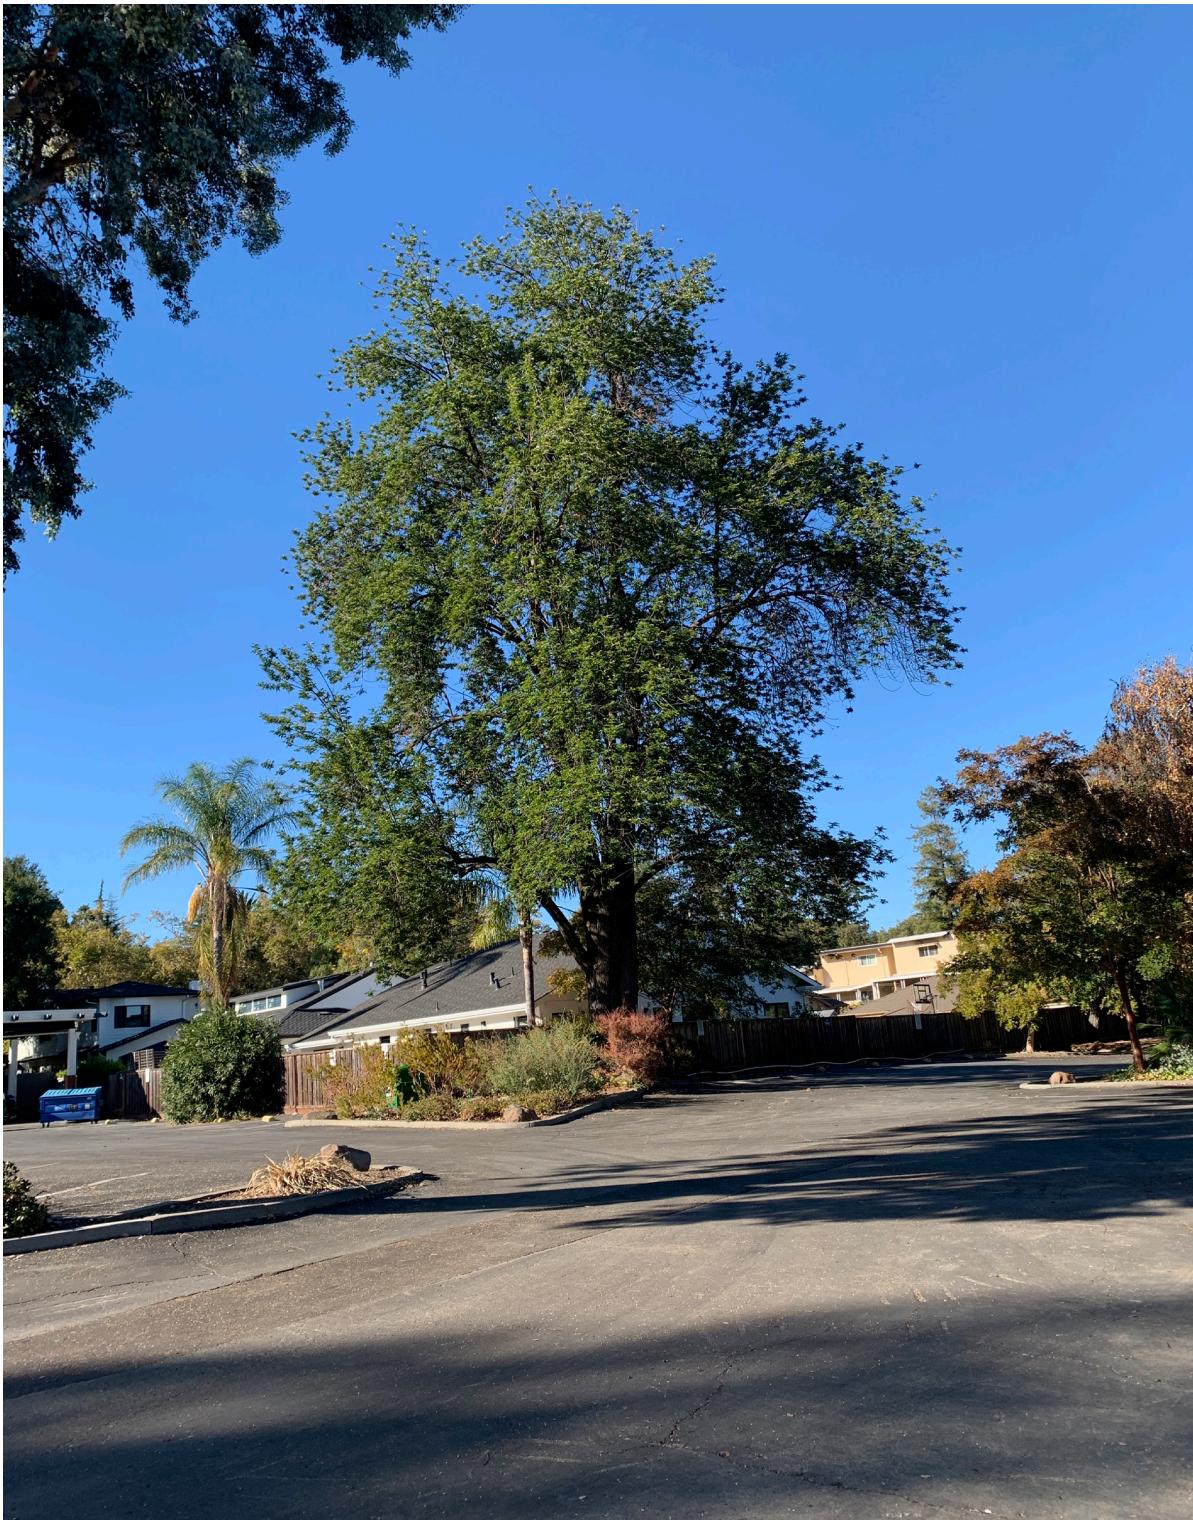
Tree #	SPECIES	DIA	S	H	RV	C	OBSERVATIONS/RECOMMENDATIONS	Impact	P	SAVE/ REMOVE
14	Shamel ash (susp.)	46	3	2.5	3	48	Located in parking lot island. Codominant branch union 6' above grade with included bark ¹ . Intertwined limbs/leaders. 'Surface' roots traveling outside curbed island buckling asphalt paving. Nest located in upper branch union (suspected rat; potentially a small raptor or other bird nest and should be verified prior to any site disturbances). <i>Proposed site improvement requires removal.</i>	Severe	P	Remorve
15	Crape myrtle	6.4	3.5	3.5	3.5	22	Located along western property line in island at upper parking area. <i>Nice specimen. Appears proposed site plan can accommodate tree. Preservation recommended.</i>	Minor	P	TBD
16	Crape myrtle	9.2	3	3	3	20	Located along western property line in island at N upper parking area. <i>Unclear whether proposed site improvements/grading can accommodate tree.</i>	Minor to moderate	P	TBD

Tree #14 Shamel ash (suspected) located in existing parking lot island. Proposed site improvements require removal.

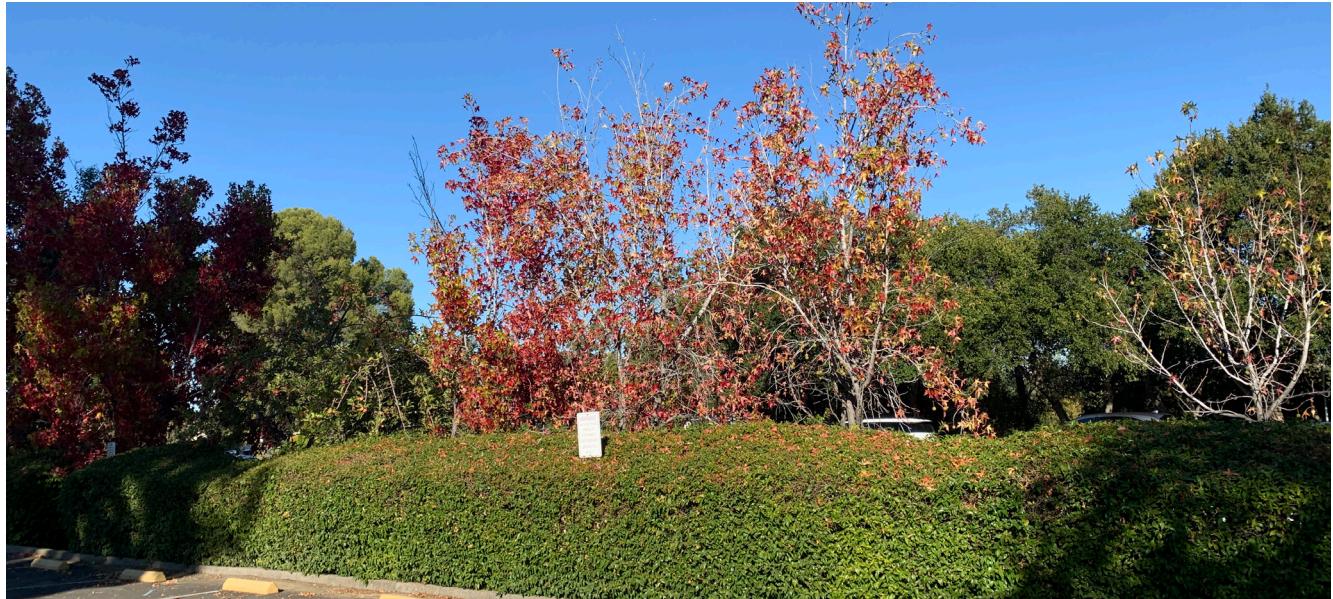
Stand of trees within the subject property along the University Avenue sidewalk, many of which are just 18" away from the sidewalk. Most of the trees are planted 9 to 10 feet on center.

TOP: (from left to right) Trees #26 - 31 (five Liquidambar and one Apple) recommended for removal based on Liquidambar's invasive roots and proximity to sidewalk, or selective removal to remediate crowding. See "Trees that Merit Special Attention."

Given the species' tendency to produce prodigious surface roots, disruptions to adjacent infrastructure (the sidewalk and curb) will likely be significantly impacted. Additionally, the close spacing between trees will not allow for proper canopy development. As noted in the tree table, the trees have been previously tagged. Per a cursory conversation with the Town, these trees may be considered as street trees (at the time of this writing, communications with the Town Arborist continue). Per the noted aggressive root system of the species, removal is recommended. As an alternative, removal of every other tree in the stand is recommended to provide a spacing of roughly 18 to 20 feet between trees.

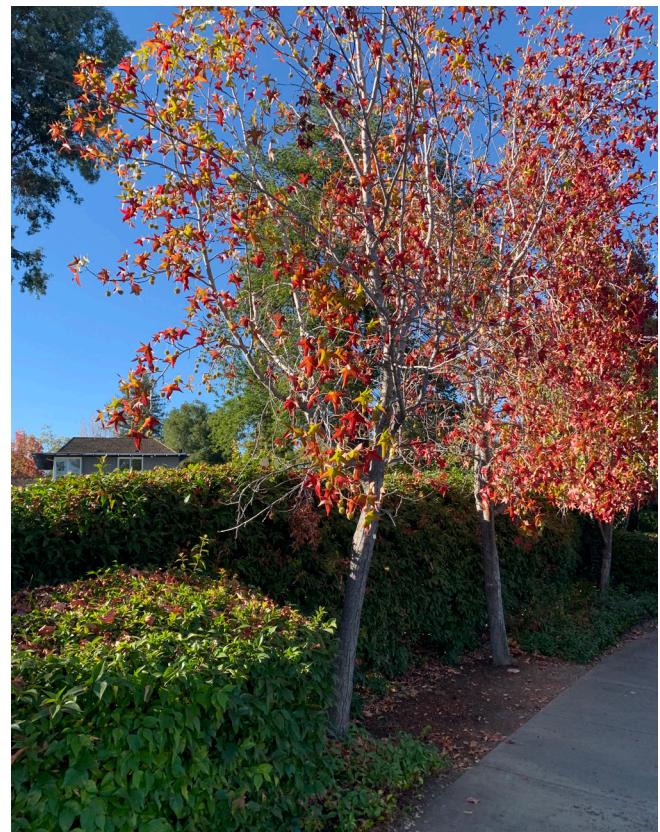
RIGHT: Trees #30 (foreground), 29, and 28, all Liquidambar, showing crowding.
