Arborist Report

**Venture Christian Church
Los Gatos, CA**

August 2025
Revised October 2025

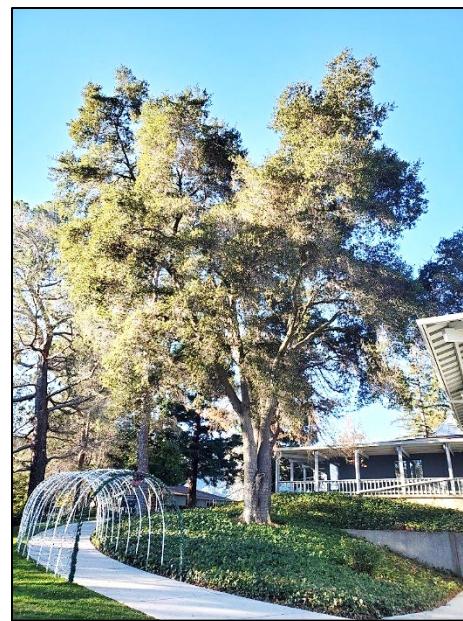
Coast live oak was the most frequently occurring species, with forty-eight (48) trees, or 18% of the population. Most (35 trees) were in fair condition with codominant or multiple attachments at one point on the trunk (Photo 1, next page). Twelve oaks were in good condition and had wide, vigorous crowns. Oak #198 was poor with a strong lean to the south. Stage of development ranged from young (6 inches in diameter) to mature (37 inches). Oaks #174 and 184 were growing off-site.

Photo 1. Coast live oak #19 had codominant stems of 37 and 29 inches and was in fair condition.

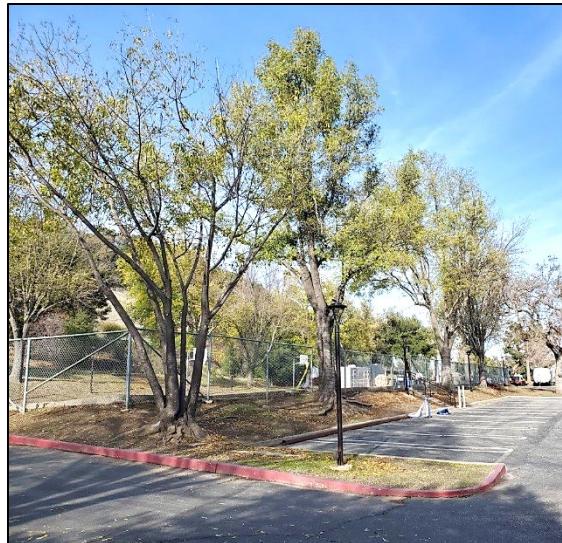
Of 25 evergreen ashes, over three-quarters were in fair condition with multiple attachments throughout the crown (20 trees). Four ashes were poor, and ash #121 was in good condition with a large vigorous canopy. Diameters were 12 to 29 inches. Several ashes in a parking lot planting strip had extensive surface roots, in some cases displacing curbs and paving (Photo 2).

Photo 2. Evergreen ashes in a parking lot had extensive surface roots.

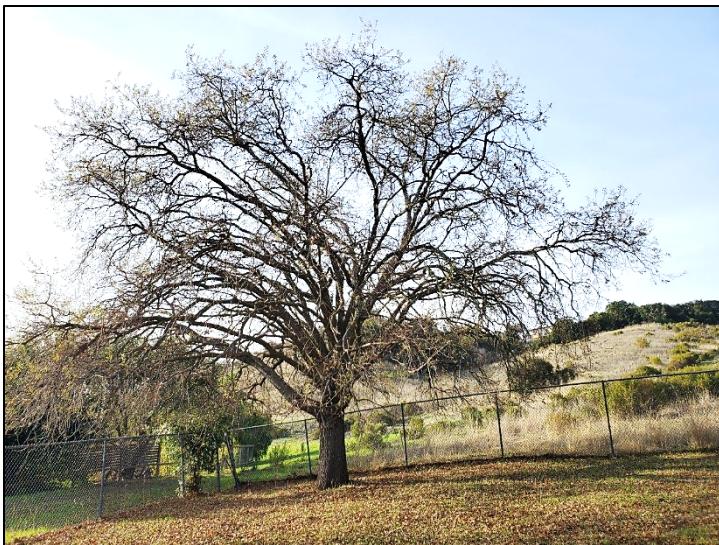
Twenty-four (24) valley oaks were growing throughout the site, with the largest trees growing in open fields to the south (Photo 3, next page). Most (18 trees) were in fair condition and crowded or suppressed by nearby shrubs and trees. Oaks #103, 165, 170, 189 and 189 were in good condition with vigorous foliage. Young valley oak #196 was poor with twig dieback and a sinuous trunk. Stage of development was very young (5 inches) to mature (35 inches). Oak #170 was growing off-site.

Photo 3. Valley oak #152 was growing in an open field at the southeast corner of the site.

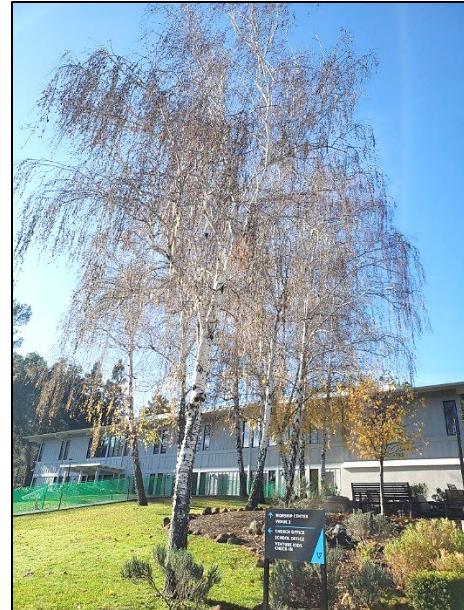
Ten (10) European white birches were growing in a crowded grove south of the main entrance to the church (Photo 4). Condition was fair (8 trees) or good (birches #13 and 15). Trees in fair condition were one-sided and had sapsucker damage. Trees in good condition were at the edges of the grove and had more growing room. Stage of development was semi-mature with diameters ranging from 9 to 15 inches.

Photo 4. European white birches #8 – 17 were growing near the main entrance to the church.

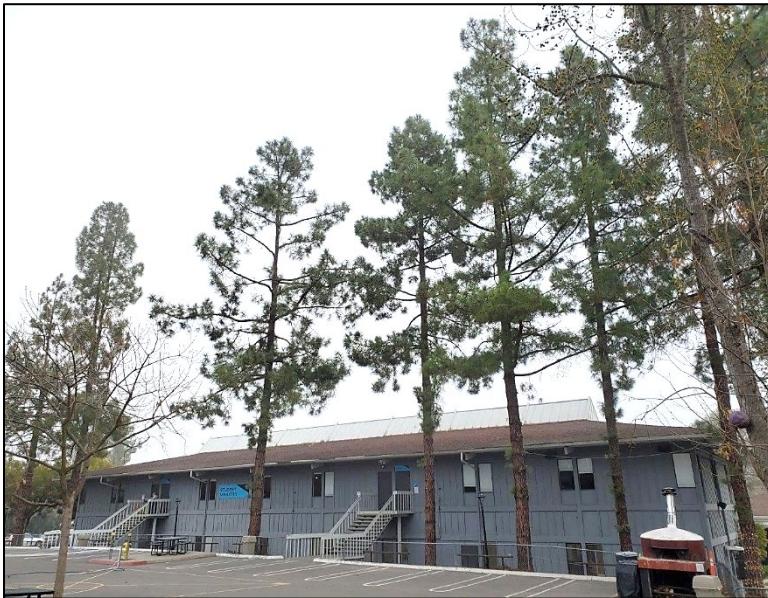
Nine Canary Island pines were growing along the sides of a classroom building (Photo 5). All were in fair condition with tall narrow raised crowns and in semi-mature stage of development, with diameters from 19 to 26 inches.

Photo 5. Canary Island pines were growing near classroom buildings.

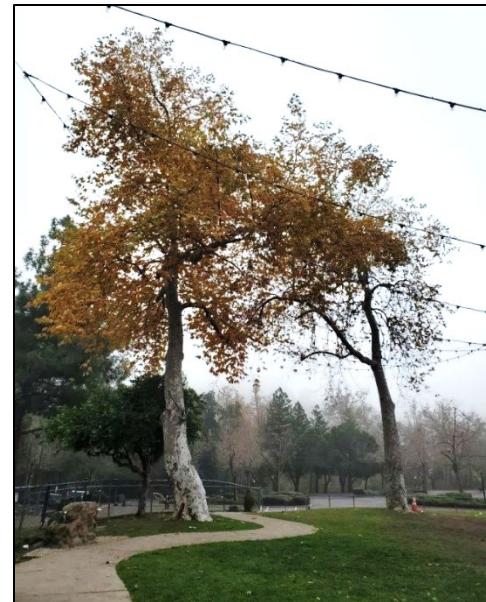
- Three mature western sycamores dominated a lawn area (Photo 6). All were in fair condition with leans, some partially corrected. Diameters were 27 to 36 inches. Sycamore #59 had a previous large branch failure near a playground.

Photo 6. Western sycamores #58 and 59 (R to L) were growing in a lawn area.
