**TREE REPORT**  
**For**  
**La Rinconada Golf & Country Club**  
**MAINTENANCE YARD UPGRADE PROJECT**  
14595 Clearview Dr. Los Gatos 95032

Lisa Edwards & Straun Edwards  
Trees 360 Degrees  
Certified Arborist #WE-5055A / #WE-5612A  
Ph. (408) 455-5911/408-898-0625

November 11th, 2025( Revised 01/29/26)

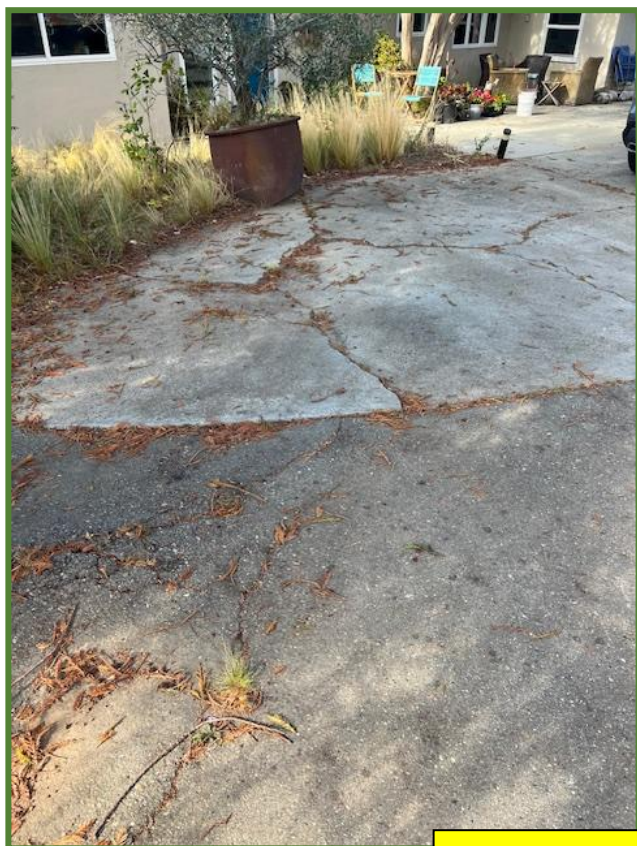
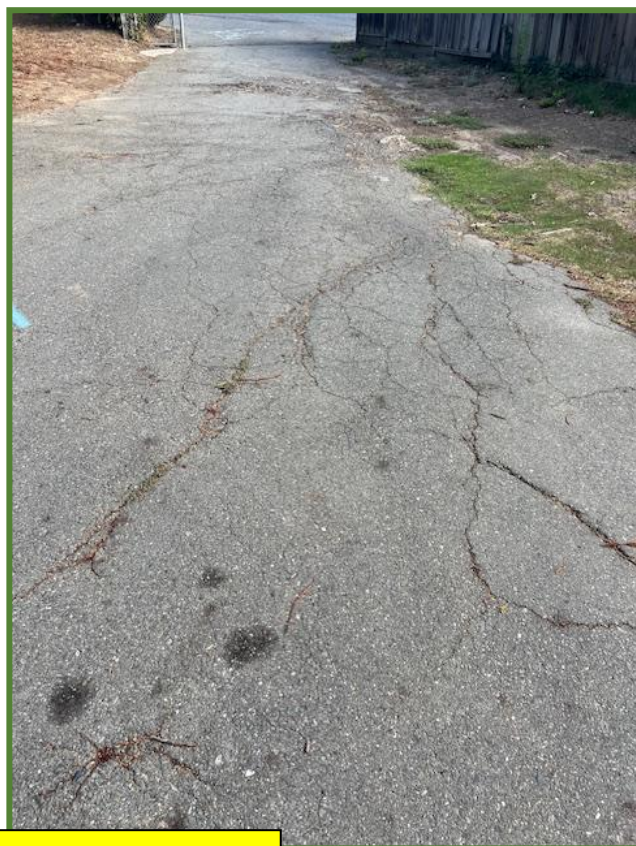
Hardscape damage due to extensive surface roots from Trees No. 947 & 948

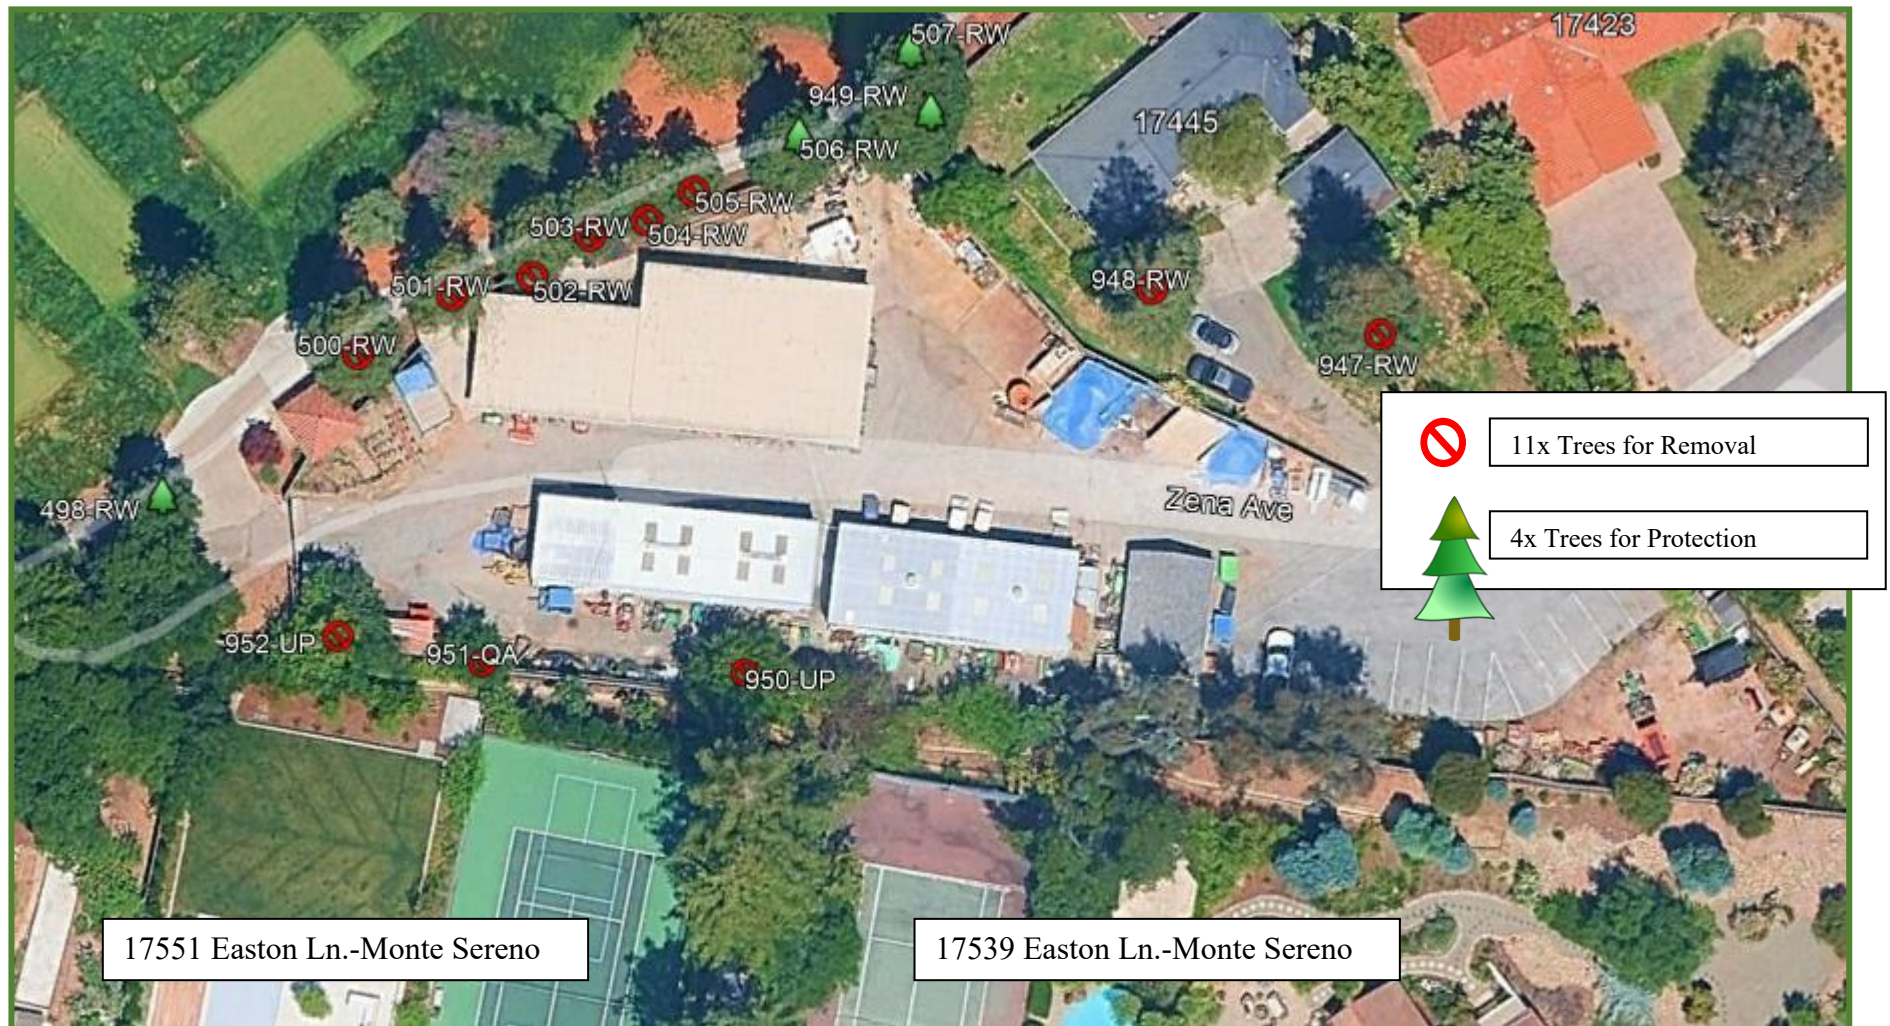
## TREE PROTECTION ZONE MAP

TPZ Chainlink fencing already in place for renovation project and recommended for additional work during the maintenance yard upgrades.

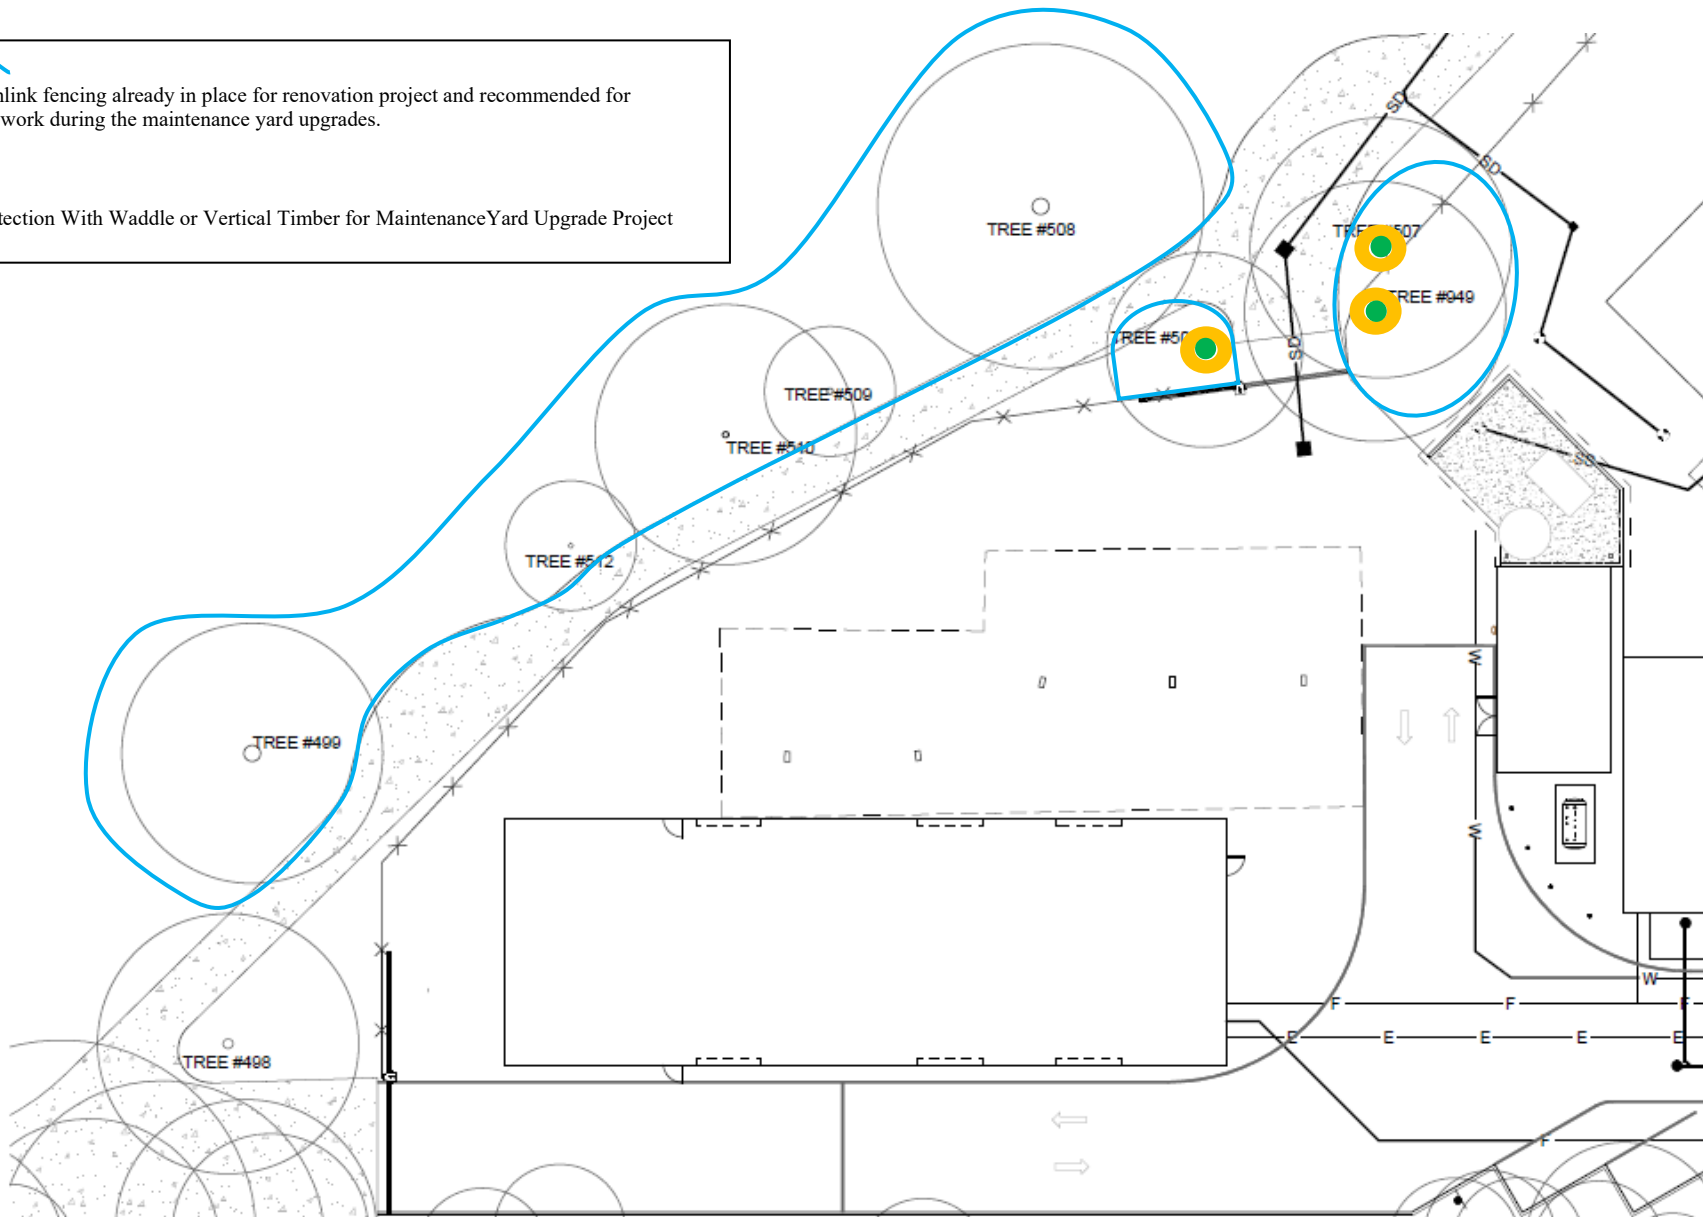
Trunk Protection With Waddle or Vertical Timber for Maintenance Yard Upgrade Project
