To: Richard Gessner **Date:** 10/20/2025
From: HMH **Job No.:** 4185.10
Subject: Response to 4th round Surrey Farms Consulting Arborist Review Letter

This letter is in response to the latest submission for 178 Twin Oaks Drive (Surrey Farms) dated July 25, 2025. Enclosed is the prior response and the applicant's response to that submission. Enclosed are the most recent peer review comments and recommendations.

1. **Comment: Lot 3:** Lot 3 has a retaining wall around the site and along the property boundary adjacent to 221 Brook Acres Drive. There are two large trees, one valley oak (*Quercus lobata*) and one coast live oak (*Quercus agrifolia*) located on 221 Brook Acres Drive not accounted for in the plans, survey, or tree detail. Trees within 30 feet of the property boundary are to be included in survey and arborist's report. There are many trees "off site" included in the report but these are not.

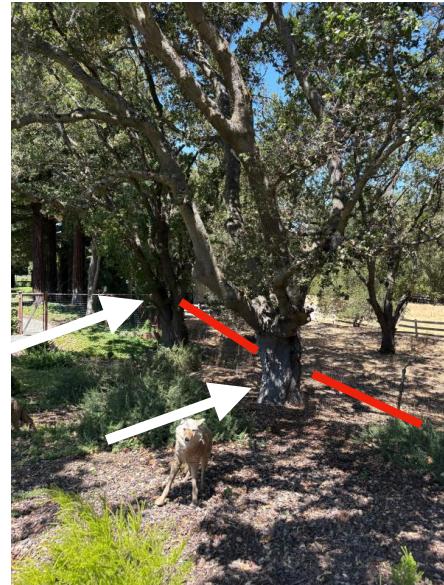
IMAGE 1: ADJACENT OAKS 221 BROOK ACRES

MCA: This item is currently unresolved. Ground observations of the tree locations do not appear to match what is indicated on the plans versus what is observed on site.

A. Recommendation: Tree protection for these two boundary trees is required. An adjustment to the wall location may be required as both trees are at or very close to the property boundary (Image 1). Include trees within 30 feet of the property in the plans and report.

- B. Recommendation:** Work performed within the drip line or twenty feet (20') of the trunks requires monitoring and documentation from the project arborist. Any work performed to the trees requires specifications in writing according to the most recent ANSI A300 document pertaining to the activity (Pruning, Soil Management etc.)

Recommendation: Please accurately locate the trees or verify their location accuracy. Please provide methodology used to obtain tree locations for the site. For example “the trees were surveyed by a California licensed engineer” or “trees were located with a GPS receiver with an error of “X” feet and plotted on a plan or aerial map”.

HMH October Response: Please see the updated Landscape T-Sheets for lot 3 and the “Overall” for updated tree 566 and 569 tree locations. The 2 trees are now listed to remain and protect. This information is reflected in the updated Arborist report as well.

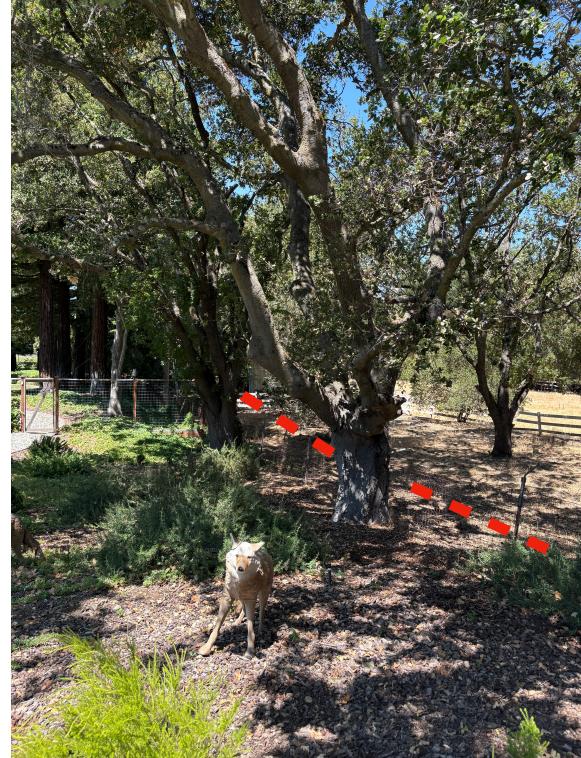
IMAGE 1: ADJACENT OAKS 221 BROOK ACRES

1. **Comment: Lot 3:** Lot 3 has a retaining wall around the site and along the property boundary adjacent to 221 Brook Acres Drive. There are two large trees, one valley oak (*Quercus lobata*) and one coast live oak (*Quercus agrifolia*) located on 221 Brook Acres Drive not accounted for in the plans, survey, or tree detail. Trees within 30 feet of the property boundary are to be included in survey and arborist's report. There are many trees "off site" included in the report but these are not.

MCA: This item is currently unresolved. Ground observations of the tree locations do not appear to match what is indicated on the plans versus what is observed on site.

- A. **Recommendation:** Tree protection for these two boundary trees is required. An adjustment to the wall location may be required as both trees are at or very close to the property boundary (Image 1). Include trees within 30 feet of the property in the plans and report.

- B. **Recommendation:** Work performed within the drip line or twenty feet (20') of the trunks requires monitoring and documentation from the project arborist. Any work performed to the trees requires specifications in writing according to the most recent ANSI A300 document pertaining to the activity (Pruning, Soil Management etc.)

Recommendation: Please accurately locate the trees or verify their location accuracy. Please provide methodology used to obtain tree locations for the site. For example “the trees were surveyed by a California licensed engineer” or “trees were located with a GPS receiver with an error of “X” feet and plotted on a plan or aerial map”.
