**ENGINEERING GEOLOGIC INVESTIGATION
PROPOSED SUBDIVISION
APN 527-27-047
14915 SHANNON ROAD
LOS GATOS, CALIFORNIA**

February 5, 2021
Project #2104

Subject: **ENGINEERING GEOLOGIC INVESTIGATION**
Proposed Subdivision
APN 537-27-047
14915 Shannon Road
Los Gatos, California

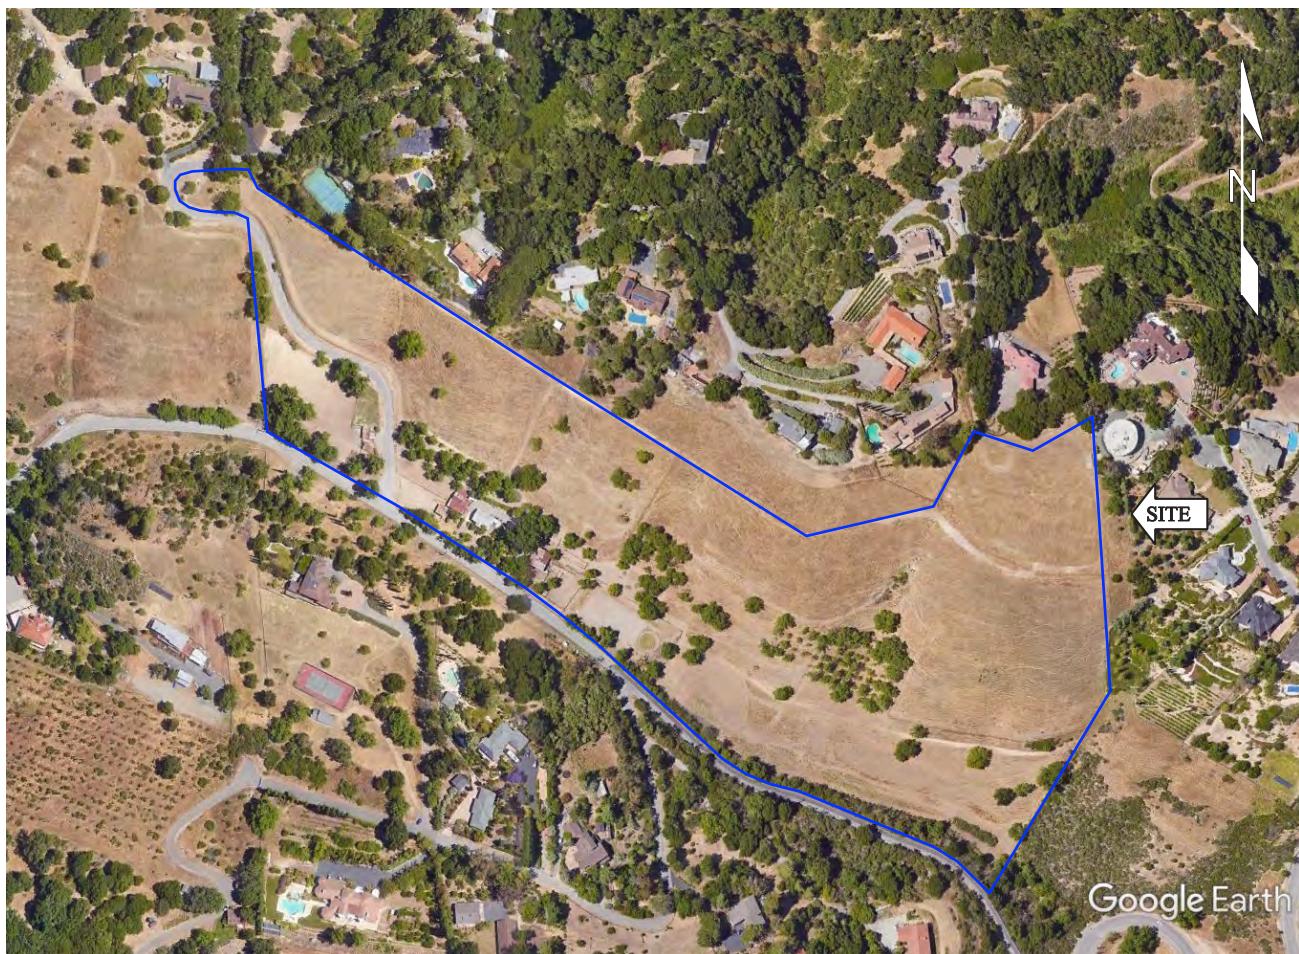
Photo 1: 2019 aerial photograph showing the subject property.

The subject property is situated within the Los Gatos foothills along the northeast flank of the northwest-trending Santa Cruz Mountain Range, as shown on Figure 2, Regional Topographic Map. The property is an irregularly-shaped 27-acre parcel located along the northeast side of Shannon Road, as shown on Photo 1 above. Sky Lane crosses the northwest corner of the property and provides access to the upper, northeast corner of the site.

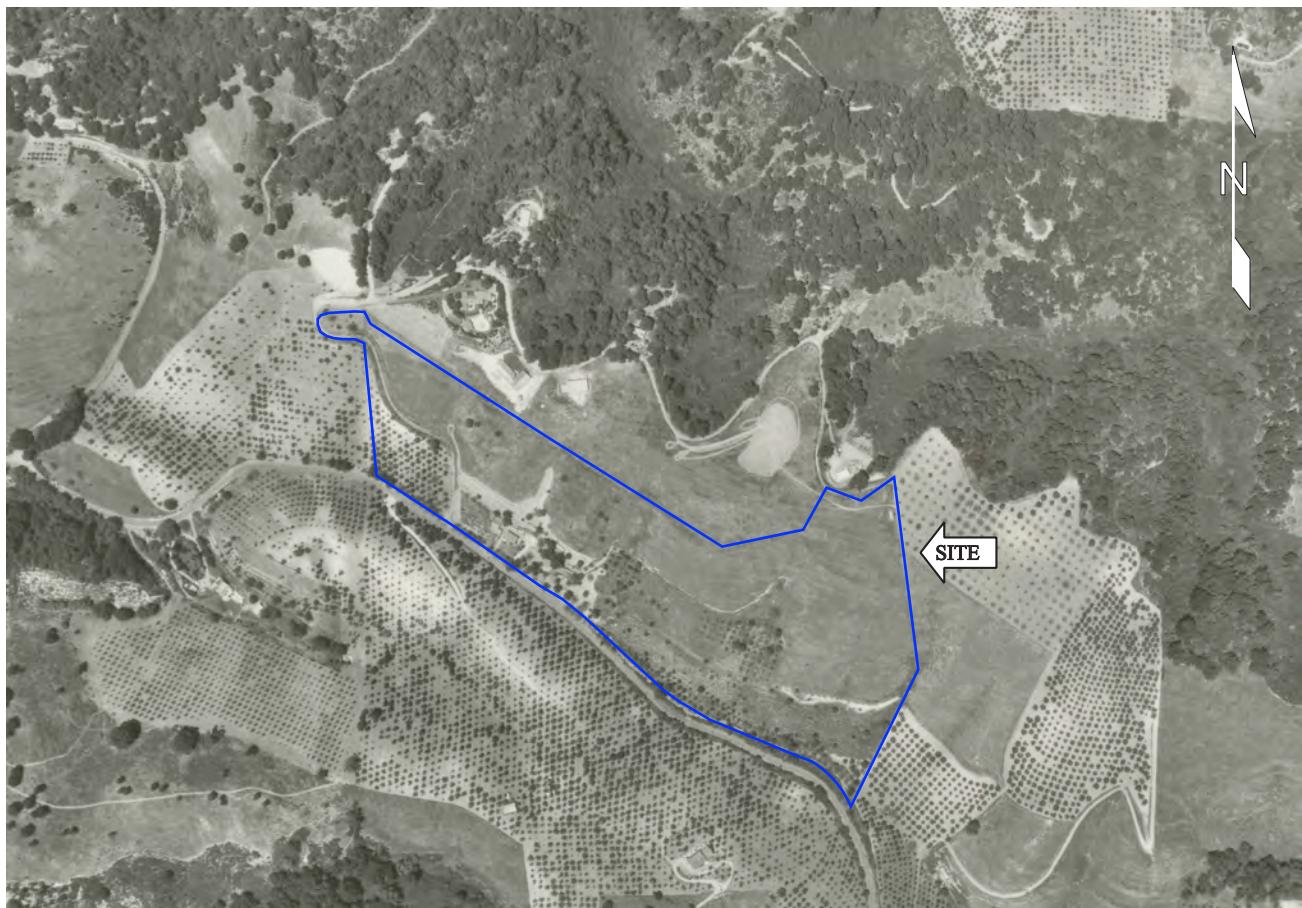
Photo 2: Aerial photograph from 1965 showing the subject property.

The subject property is clearly visible in the photos reviewed, as shown on Photo 2 above. The property is located along the southwest flank of a prominent northeast-trending ridgeline. Shannon Road, Sky Lane, and the existing residence were constructed sometime prior to the 1956 photo date. Significant grading does not appear to have occurred on the property. More extensive fruit orchards were located on the property in the past than today.

Evidence of recent landsliding or faulting, in the form of fresh scarps, ground cracking, soil lineations, or disturbed vegetation, however, is not apparent on the subject property in the air photos reviewed. Recent debris flow tracks were not observed on the property, however, steeply-inclined swales appear to be potential debris flow source areas.

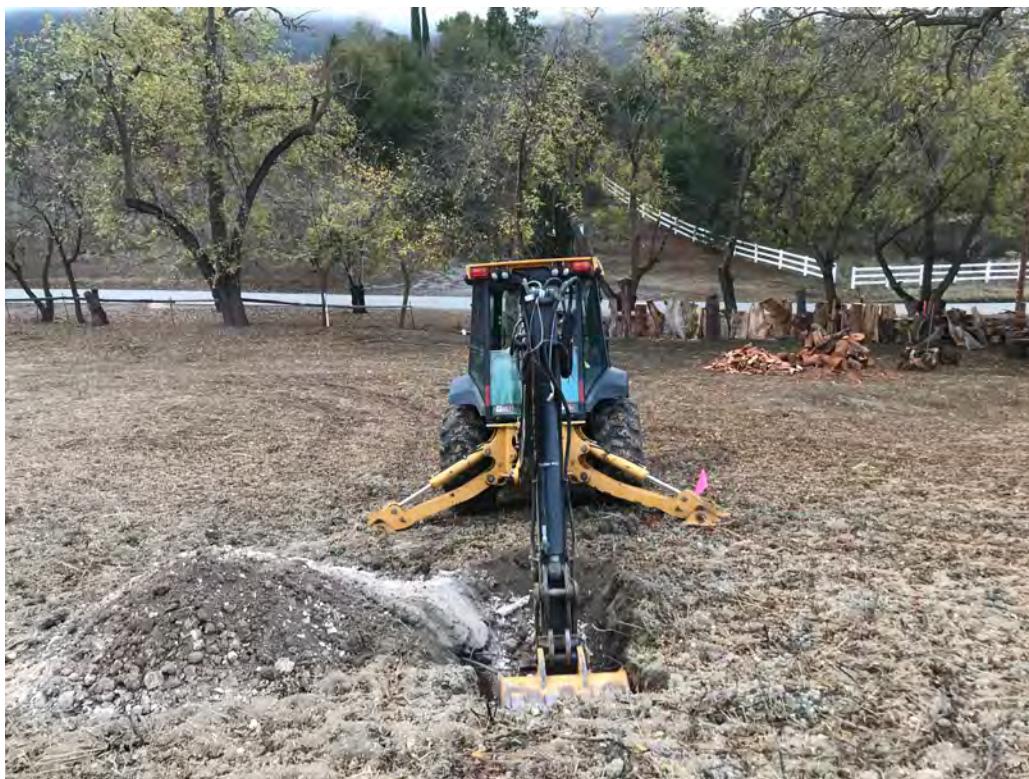
As part of this investigation, eleven test pits were excavated on the property, in the approximate locations shown on Figure 7, using a backhoe (see Photo 5 below). Detailed logs of the materials encountered in the test pits are shown on Figures 8 through 18.

Photo 5: View of backhoe excavating Test Pit 1.

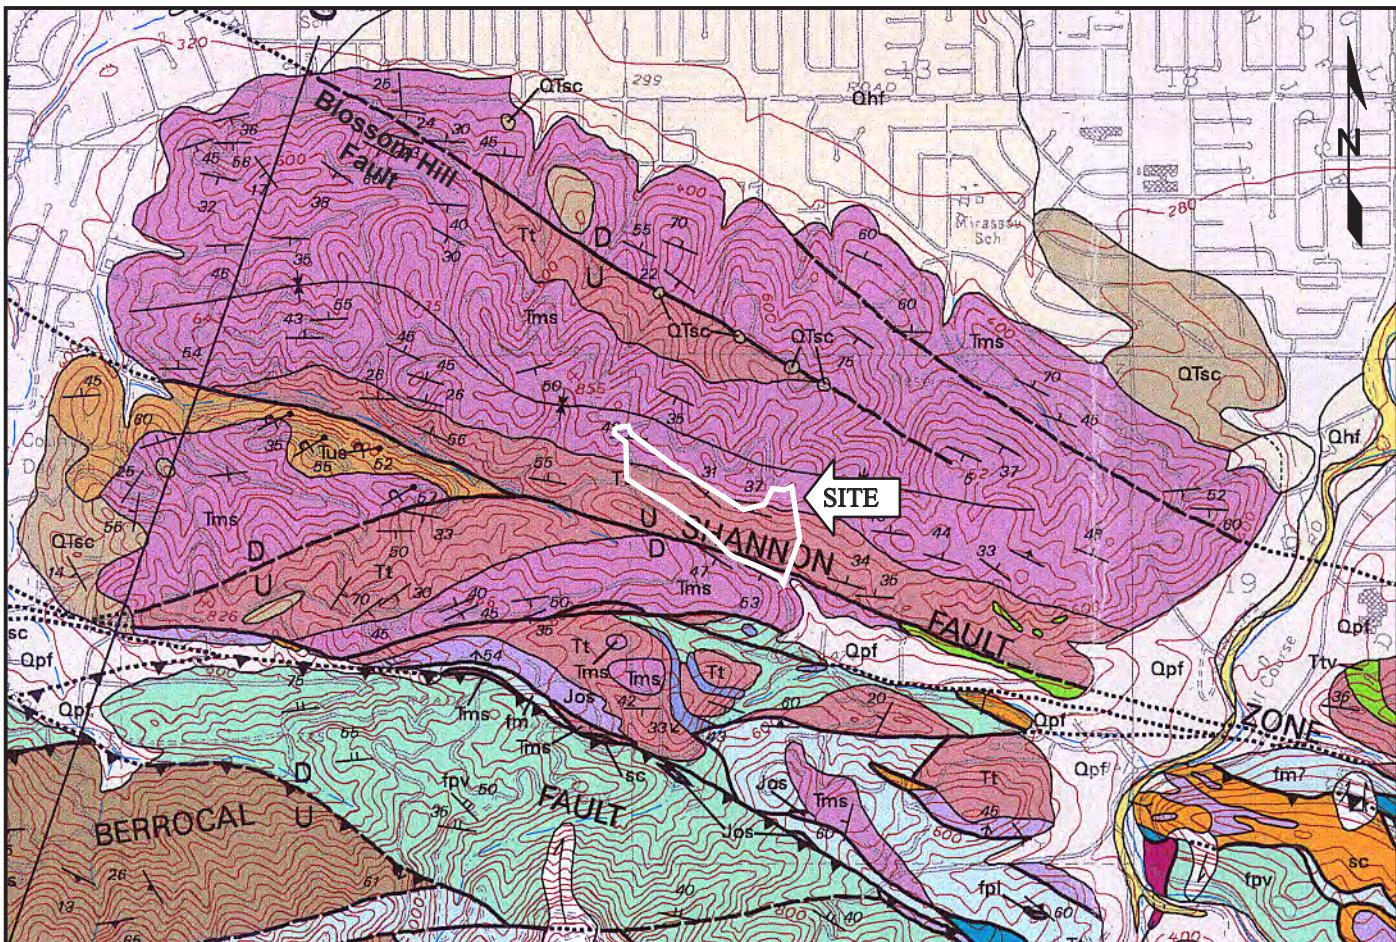
Project #	Scale	Date	Figure
2104	1 Inch = 2000 Feet	2/5/21	3

As previously discussed, the Shannon fault has been mapped through the southwest margin of the property, as shown on Figure 3, Regional Geologic Map, Figure 4, Town Geologic Hazards Map, and Figure 7, Site Geologic Map. The Shannon fault and other range front thrust faults are considered active. The nearby Blossom Hill fault (see Figure 3) was identified by Steven F. Connelly, C.E.G. (2003) as an active fault.

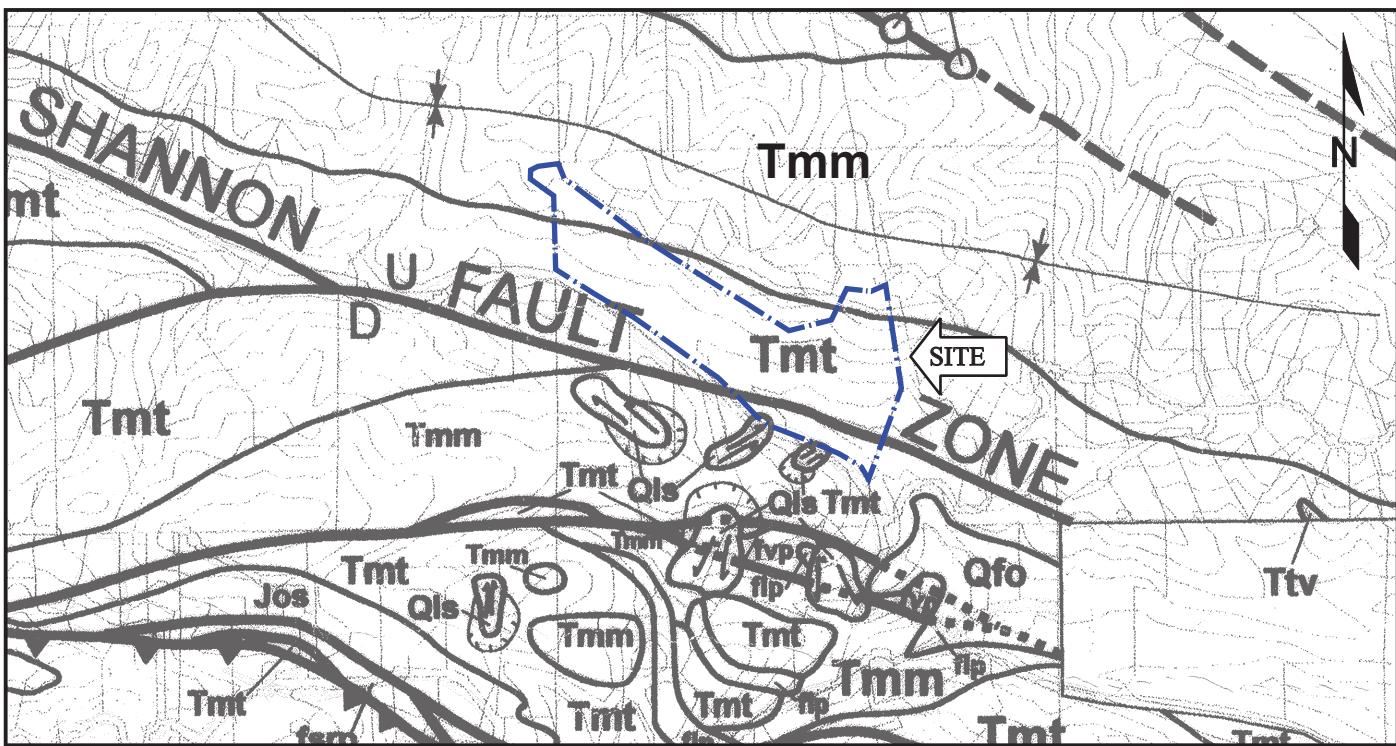
Town Geologic Hazards Map	APN 537-27-047		
STEVEN F. CONNELLY, C.E.G.	14915 Shannon Road		
<i>Consulting in Engineering Geology</i>	Los Gatos, California		
Project #	Scale	Date	Figure
2104	1 Inch = 1000 Feet	2/5/21	4

Nolan Associates (2002) identified similar geologic relationships on a geologic hazards map produced for the Town of Los Gatos, as shown on Figure 4, Town Geologic Hazards Map. Landslide deposits are not mapped on the property. Landslides, however, are mapped to the south on the opposite side of Shannon Road.

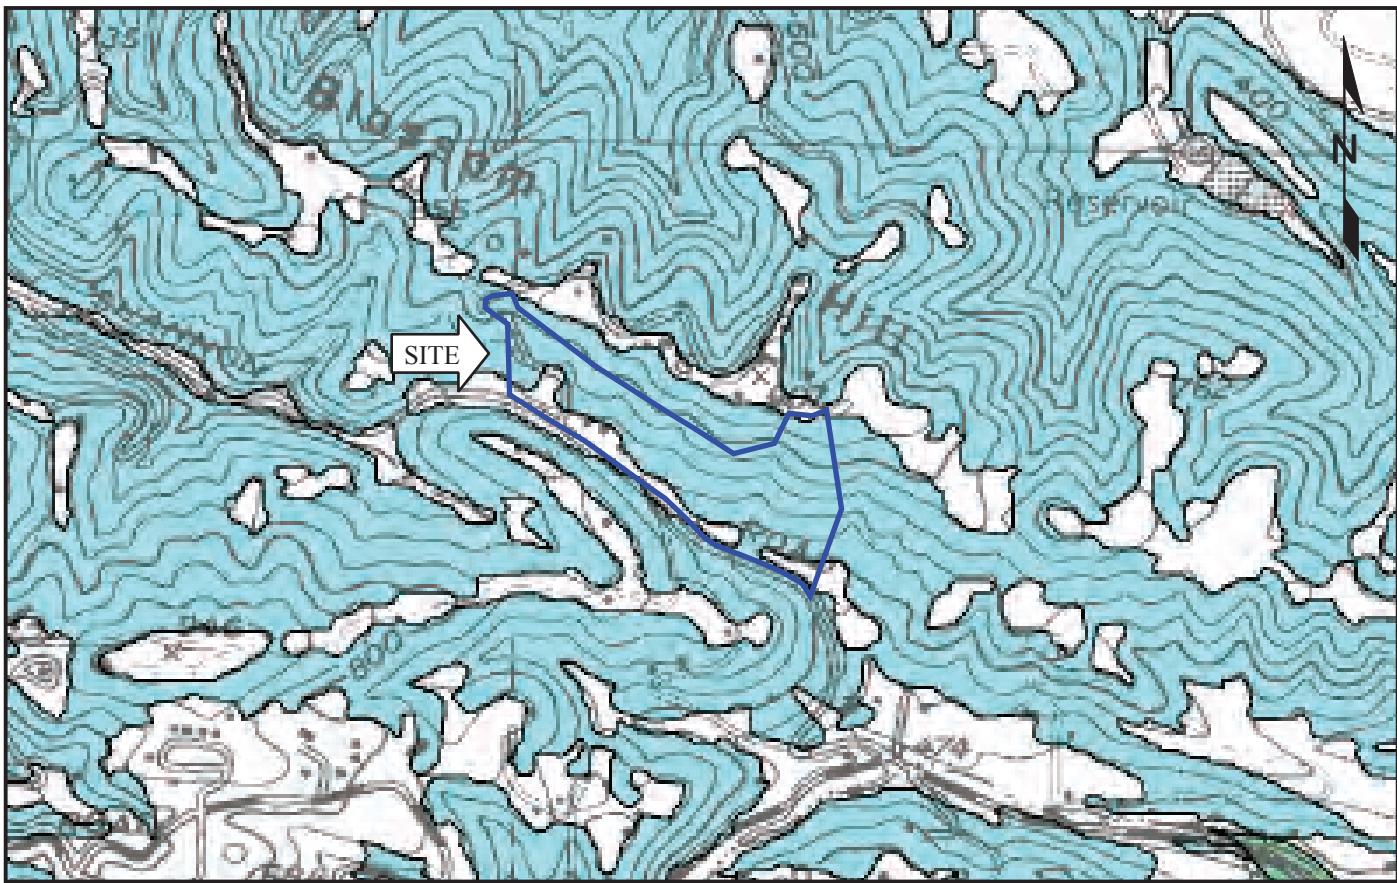
Project #	Scale	Date	Figure
2104		1 Inch = 1000 Feet	2/5/21	5

The California Geological Survey (2002) has mapped most of the subject property within a State Seismic Hazard Zone, susceptible to potential seismically-induced landsliding, as shown on Figure 5, State Seismic Hazard Zone Map. The hazard zone mapping for the subject property appears to be based on slope inclinations and not on any particular mapped landslide deposit. The level to gently-inclined area of the property adjacent to Shannon Road is not within a landslide hazard zone.

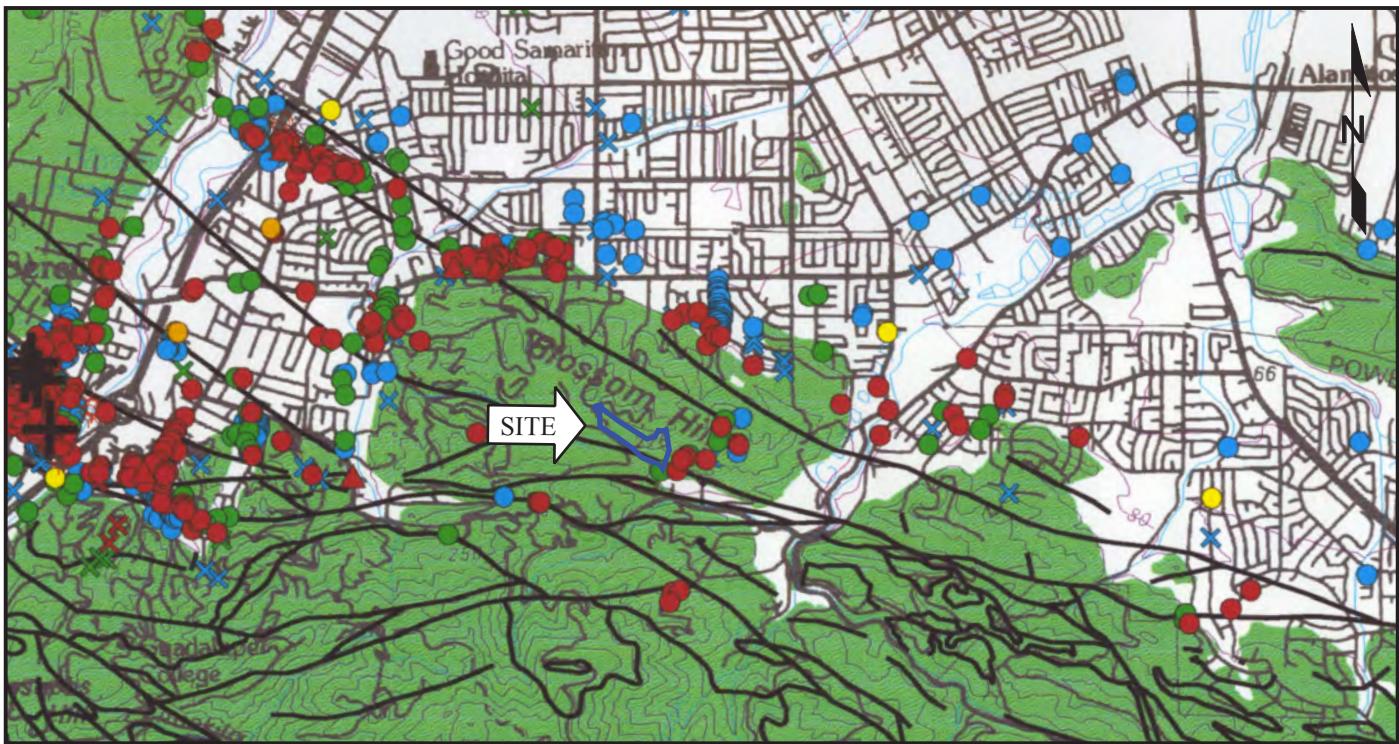
may be currently active. Schmidt and others (1995) identified damage to pavement and pipes associated with the Loma Prieta Earthquake, as shown on Figure 6, Map of 1989 Coseismic Deformation. Extensive damage was noted just to the east of the subject property.

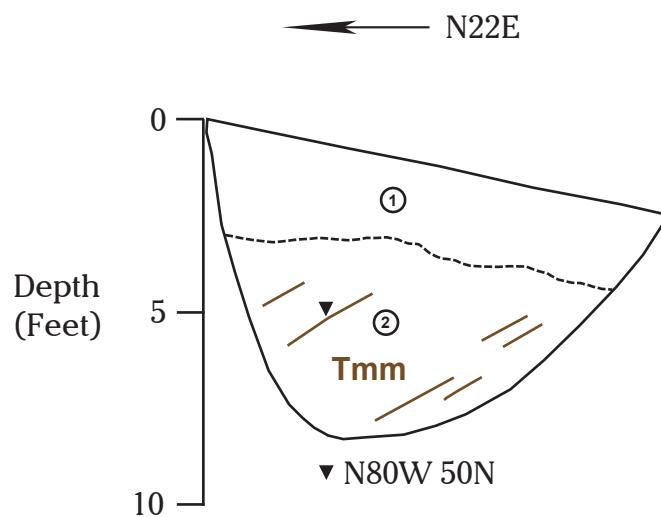
Test Pit 1 was excavated on Lot 1 and encountered about 2.5 feet of colluvial soil, composed of firm to stiff, low plasticity, silty clay. Weathered bedrock of the Monterey Shale composed of moderately bedded, moderately hard, siltstone and shale with white carbonate staining was observed, as shown on Photos 6 and 7 above. Bedding measured in Test Pit 1 strikes North 80 West and dips 50 degrees towards the North.

- ① dark grayish brown, 10YR6/2, silty clay, slightly moist, firm to stiff, low to medium plasticity, trace roots and rootlets, CL (Colluvial Soil)
- ② white, 10YR8/1 to very pale brown, 10YR7/3, siltstone and shale, moderately hard, lithified, moderately bedded, stained with white calcium carbonate (Weathered Bedrock, Monterey Shale)

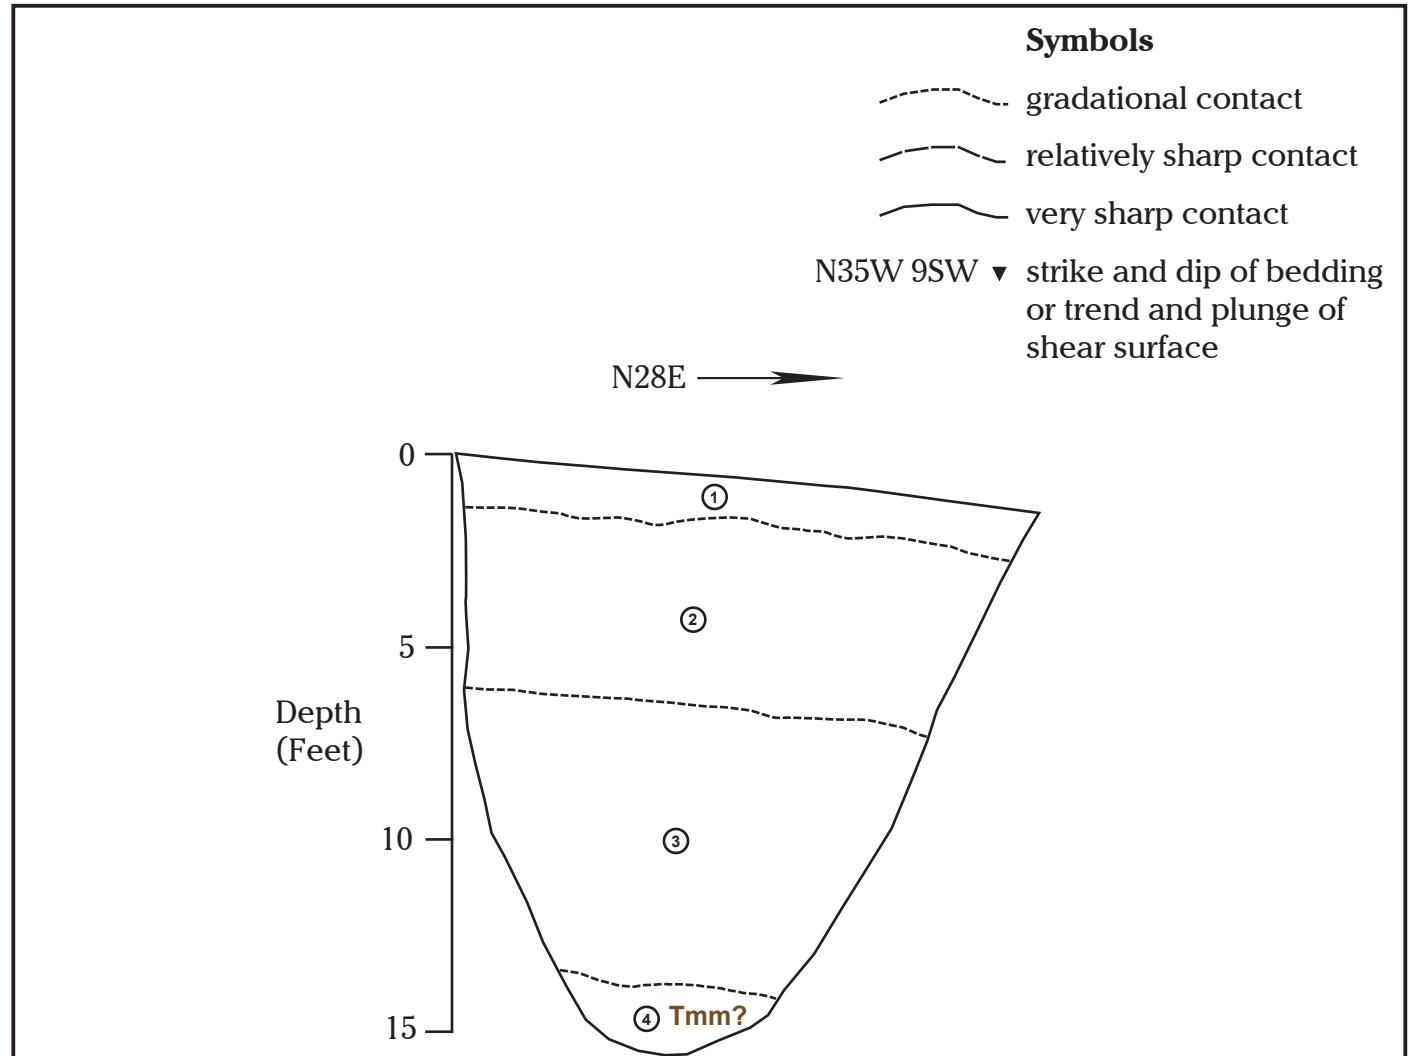
Test Pit 5 was excavated within the broad drainage swale along the southwest margin of Lot 7. Thick deposits of colluvial soil or slope wash were encountered to a depth of about 13 feet. Highly weathered, slightly sheared, claystone was observed at the bottom of the pit. The claystone is assumed to be Monterey Shale, however, this identification is questionable due to the severe weathering of the bedrock.

- ① dark grayish brown, 10YR6/2, silty clay, slightly moist, firm to stiff, low to medium plasticity, trace roots and rootlets, CL (Tilled Topsoil)
- ② black, 10YR2/1, silty clay, slightly moist, very stiff to hard, high plasticity, trace rock fragments of Monterey Shale to 1/2 inch (Colluvial Soil)
- ③ dark grayish brown, 2.5Y4/2, silty clay, slightly moist, hard to very hard, high plasticity, (Colluvial Soil/Slope Wash)
- ④ light yellowish brown, 2.5Y6/4, claystone, highly weathered, slightly sheared, (Highly Weathered Bedrock/Monterey Shale?)

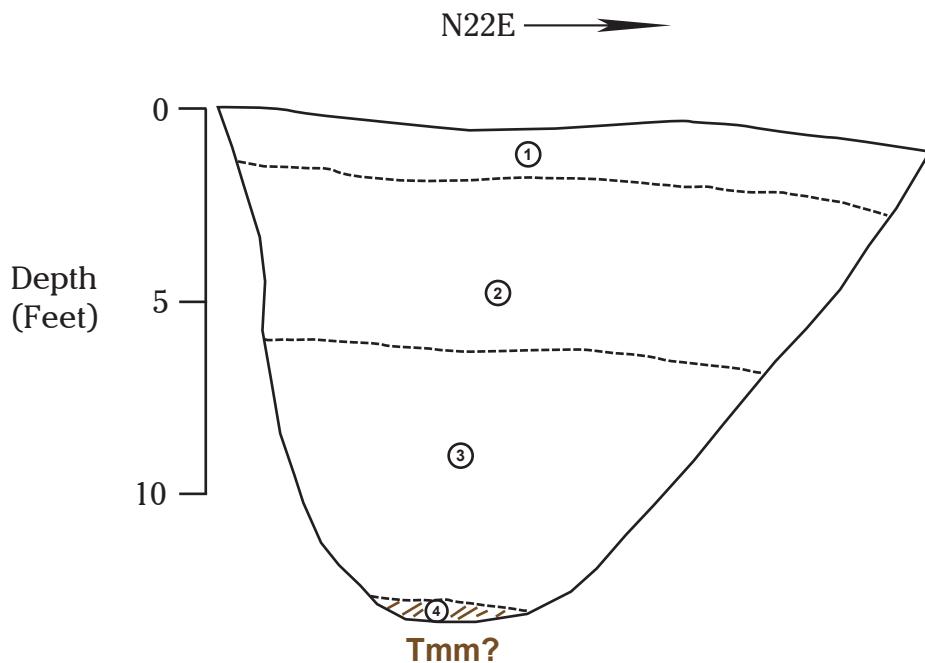
Test Pit 10 was excavated near the southwest edge of the property on Lot 7. Thick deposits of colluvial soil or slope wash were encountered to a depth of about 12 feet. Highly weathered, slightly sheared, claystone was observed at the bottom of the pit. Due to severe weathering the claystone bedrock is also assumed to be Monterey Shale.

- ① dark grayish brown, 10YR6/2, silty clay, slightly moist, firm to stiff, low to medium plasticity, trace roots and rootlets, CL (Tilled Topsoil)
- ② black, 10YR2/1, silty clay, slightly moist, very stiff to hard, high plasticity, trace rock fragments of Monterey Shale to 1/2 inch (Colluvial Soil)
- ③ dark grayish brown, 2.5Y4/2, silty clay, slightly moist, hard to very hard, high plasticity, (Colluvial Soil/Slope Wash)
- ④ light yellowish brown, 2.5Y6/4, claystone, highly weathered, slightly sheared, (Highly Weathered Bedrock, Monterey Shale?)
