**RE: 62 Ellenwood Avenue**

I reviewed the drawings, and evaluated the site context. I am familiar with the site from previous reviews in the neighborhood. My comments and recommendations on the design are as follows:

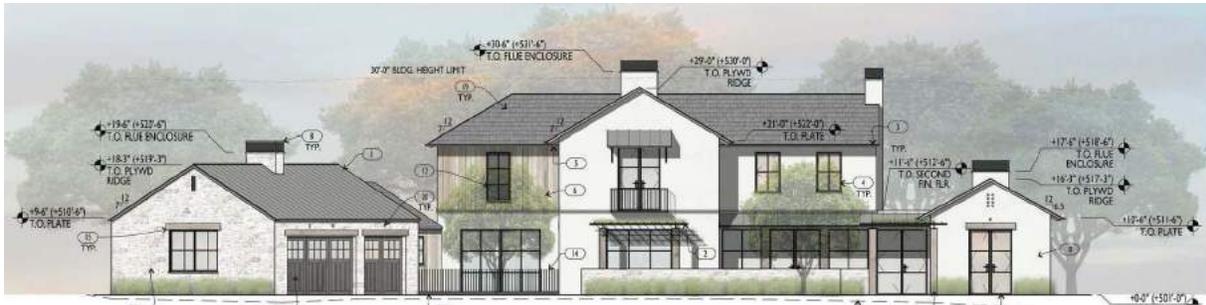
*Proposed Front Elevation*

The proposed house is well designed in a traditional style with substantial facade articulation, variations in height, and high quality materials. Windows are recessed from the outside face of the walls and additional landscaping would be installed - see proposed elevations below.

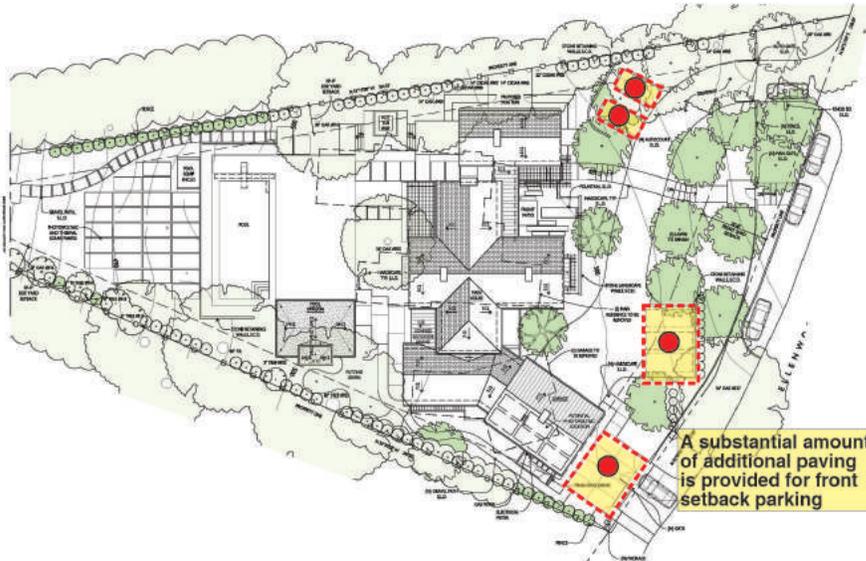
1. The additional landscaping in the front setback will be a welcome feature to integrate the home into the surrounding neighborhood, but the substantial additional paving proposed to provide at least six additional parking spaces seems out of character with the immediate neighborhood.

**Recommendation:** Remove some of the additional paving.

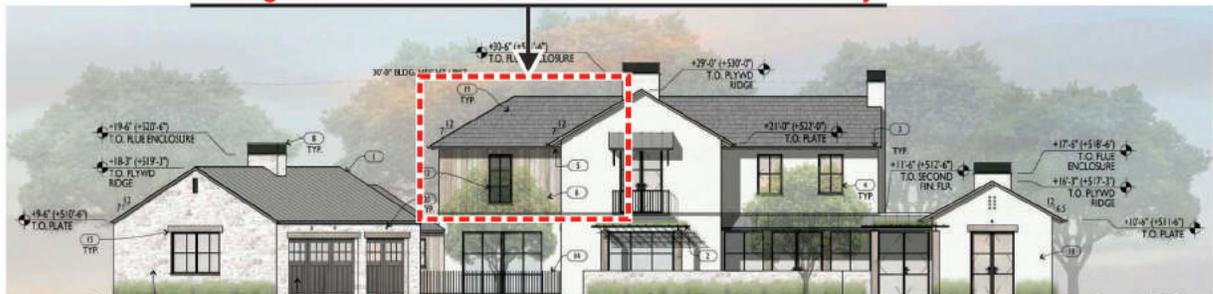
2. The change in roof form and wall materials on the second floor south wing of the house seems arbitrary, and an unwelcome change from the traditional forms and simplicity of the house style.

**Change in roof form and wall material seems arbitrary**

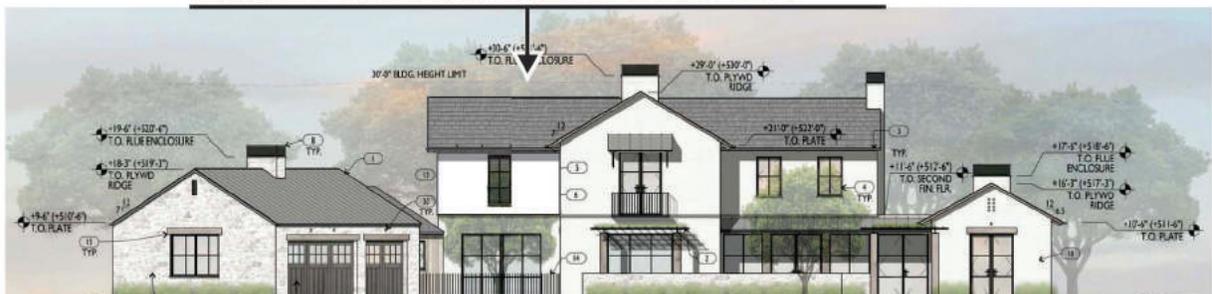
**Recommendation:** Match the roof form and wall material of the other second floor masses.

**Match roof form and wall material of other roofs**

**Note:** Given the separation of the garage from the main house form, the use of stone and metal roofing seems acceptable.

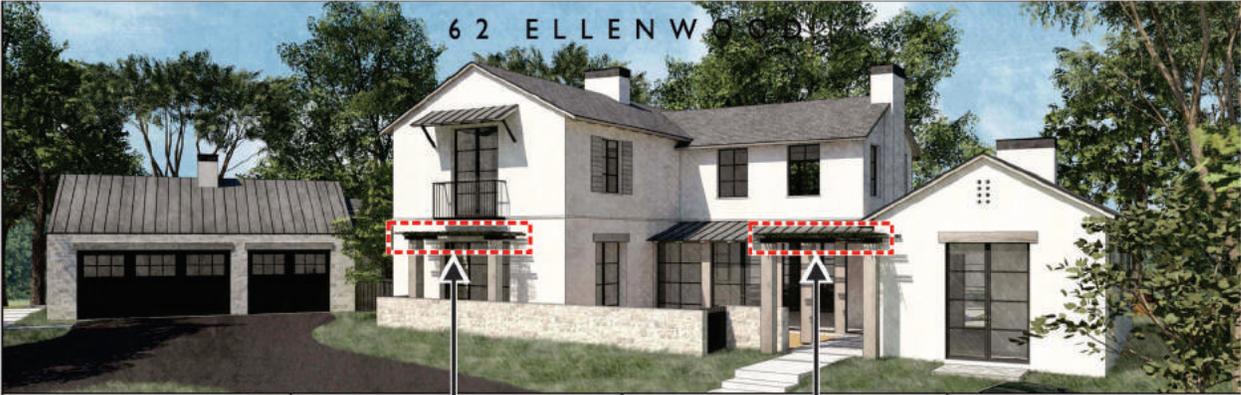
3. The metal trellis elements seem too small for the large cedar wood columns.

**Trellis seem small in scale compared to large wood columns**

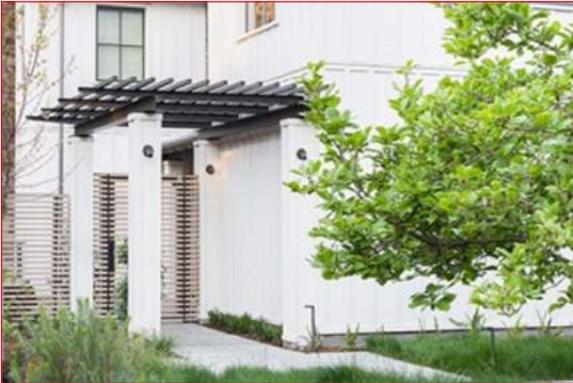
The architect appears to have used a somewhat similar scale on one of their other projects - see photo below.

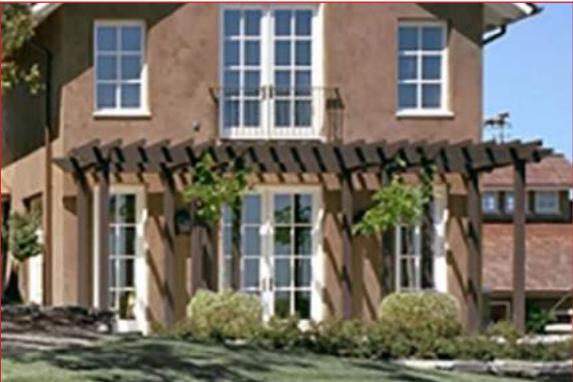
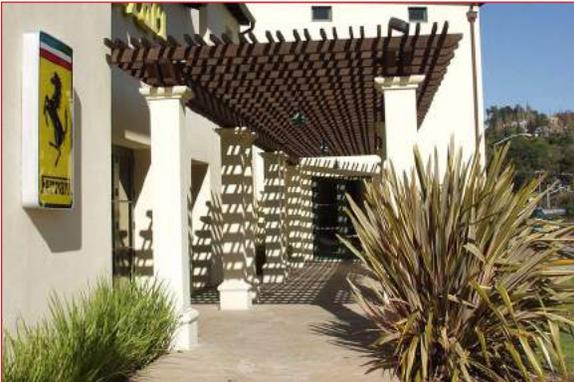
**Recommendation: Consider adjusting the scale of the trellis and/or the columns - see examples below.**

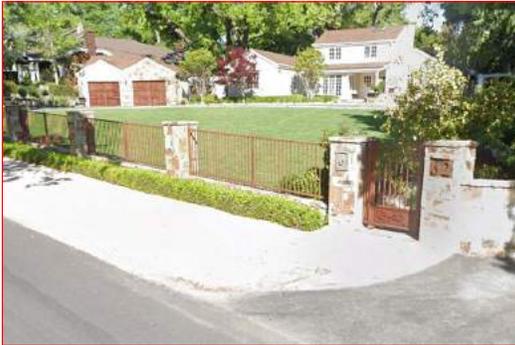
*Existing parcel fence*

4. The proposed fencing along the Ellenwood Avenue edge has some stone features at auto and pedestrian entries, but appears to be a uniform picket fence without additional elements or buffer landscaping along the remainder of the edge as is common on other nearby properties.

**Front fence is taller and lacking in visual variety compared to other nearby homes**
